STREAM MIGRATION AND SEDIMENT MOVEMENT ON LOWER CACHE  
CREEK FROM CAPAY DAM TO INTERSTATE 5 AT YOLO, CA

THESIS

GEOLOGY

CALIFORNIA STATE UNIVERSITY, SACRAMENTO

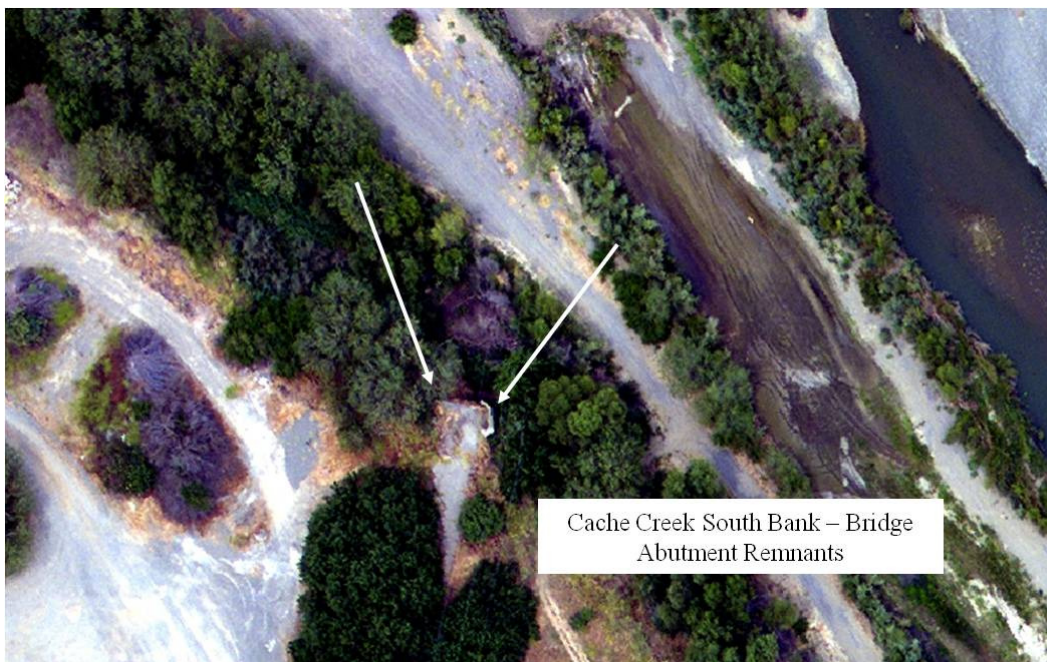
Figure 1.10 Bridge Abutments CR 89 – 2006

construction of the Federal Highway System came a need to build additional bridges over Cache Creek. The new bridges were the I-505 Bridge near the town of Madison and the I-5 Bridge near the town of Yolo (Figure 1.9). More care was taken in the construction of these bridges; however, the I-505 Bridge design has a vane structure that redirects flow of water in Cache Creek. Due to the constriction of the channel, several bridges have been damage or destroyed over time. In 1940 and 1941, the CR 94B Bridge (Stevens Bridge) and the CR 85 Bridge (Capay Bridge) respectively were washed out by large flood events. Both bridges were reconstructed in 1947 (NHC, 1995). The CR 89 Bridge (Madison Bridge) collapsed in 1978 and was never replaced (NHC, 1995). Bridge abutments can still be seen today at this site (Figure 1.10).

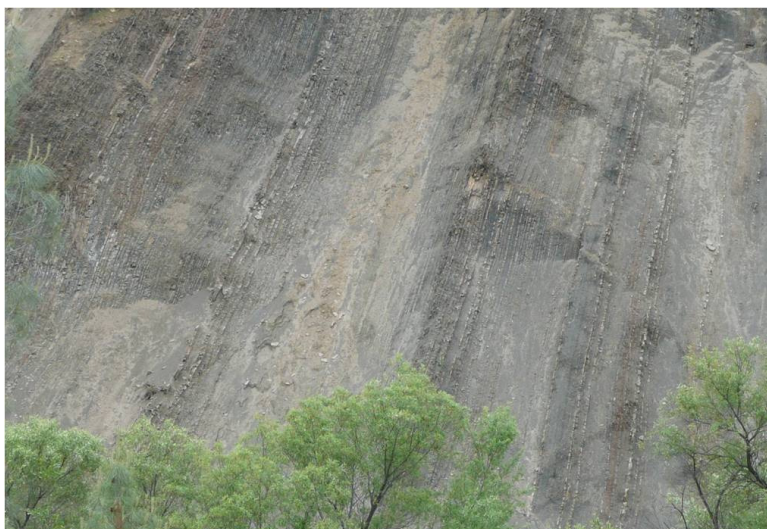
Figure 2.3 Deformed Strata - Cache Creek Regional Park (Tami Leathers, 2010)

1964) (Figure 2.3). The study is conducted primarily in the Great Valley Sequence and several younger formations; although many rocks from the Franciscan Assemblage can be found in the channel due to sediment transport from the Capay Valley Reach.

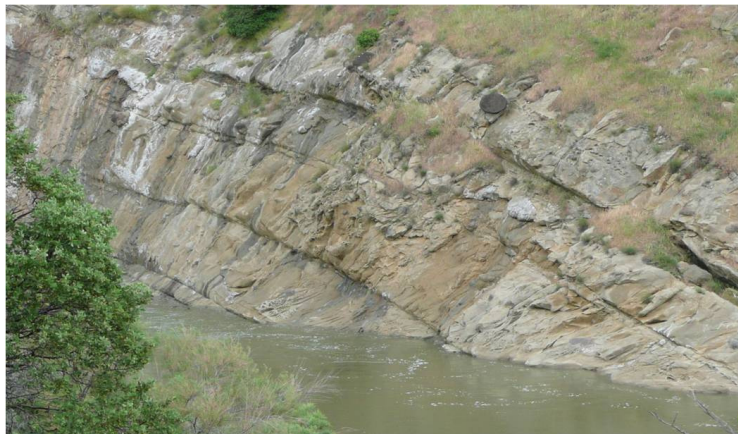
Figure 2.5 Photograph of Deformed Strata near Camp Haswell (Tami Leathers, 2010)

Canyon walls of the upper portion of the Capay Valley Reach consist of moderately erodible sandstone, shale, and conglomerate of the Cretaceous Great Valley Sequence (Figure 2.5).

Much of the aggregate mined

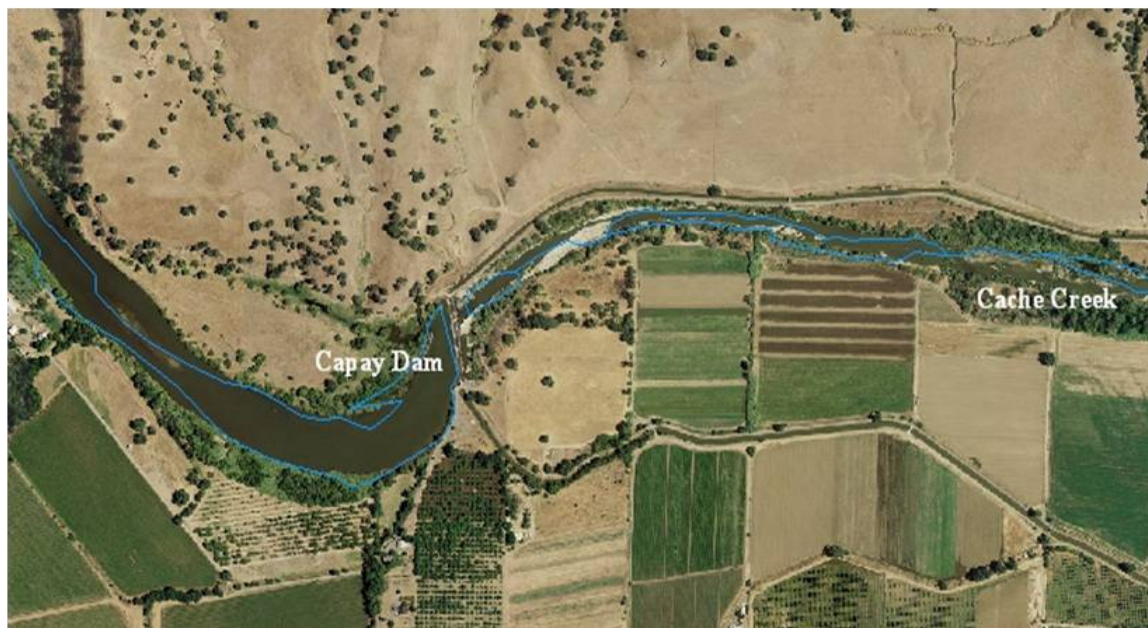
Figure 2.6 Aerial Photograph of Capay Diversion Dam on Cache Creek

from the lower reaches originated from these rocks. At the downstream end of the Capay Valley Reach, Cache Creek turns toward the east where the Capay Diversion Dam is located (Figure 2.6).

At this location, the creek widens as the dam holds back water that is diverted into irrigation canals during peak agricultural growing season. Maximum diversion occurs from March through October of each year.

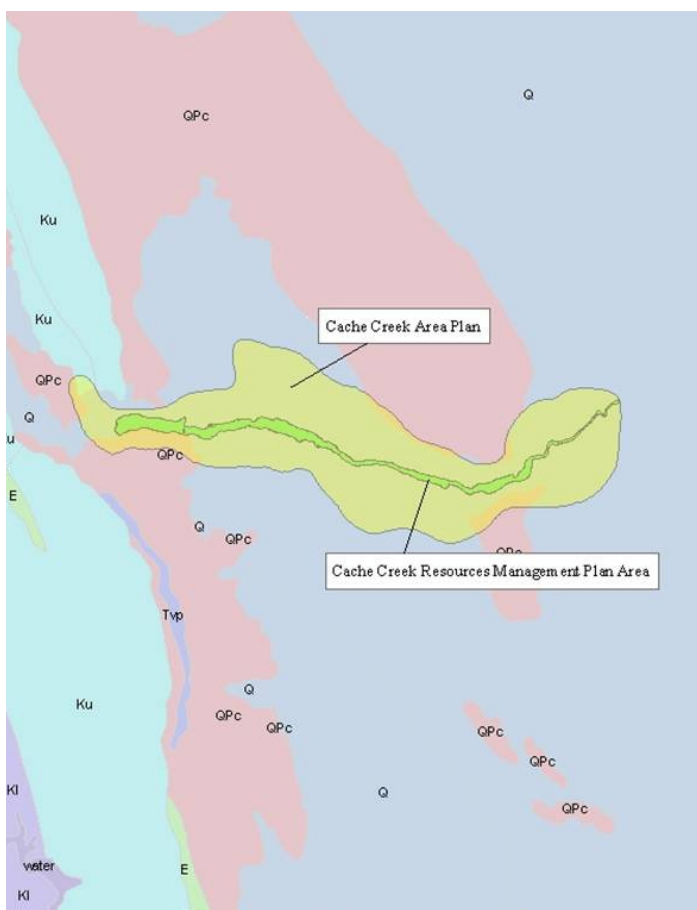
Figure 2.7 Geologic Map of Study Area

This study is focused on the lower reaches of Cache Creek from the Capay Dam to the Interstate 5 Bridge Overcrossing near the town of Yolo (Figure 1.1). In this area, Cache Creek flows through the Tehama Formation, the Red Bluff Formation, the

Modesto and Riverbank Formations, and Natural Channel and Levee Deposits (Figure 2.7).

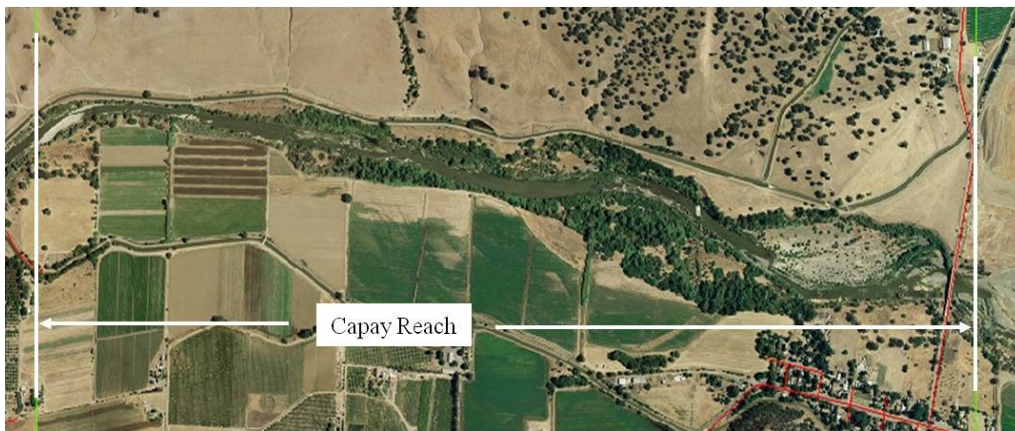
Figure 2.8 Aerial Photograph of Capay Reach

Moderately dense riparian vegetation is present along both banks (Figure 2.8). Within the Capay Reach, the channel narrows by a factor of 2.6 at the County Road 85 Bridge. Immediately downstream of the bridge the channel widens dramatically and an active, braided section forms.

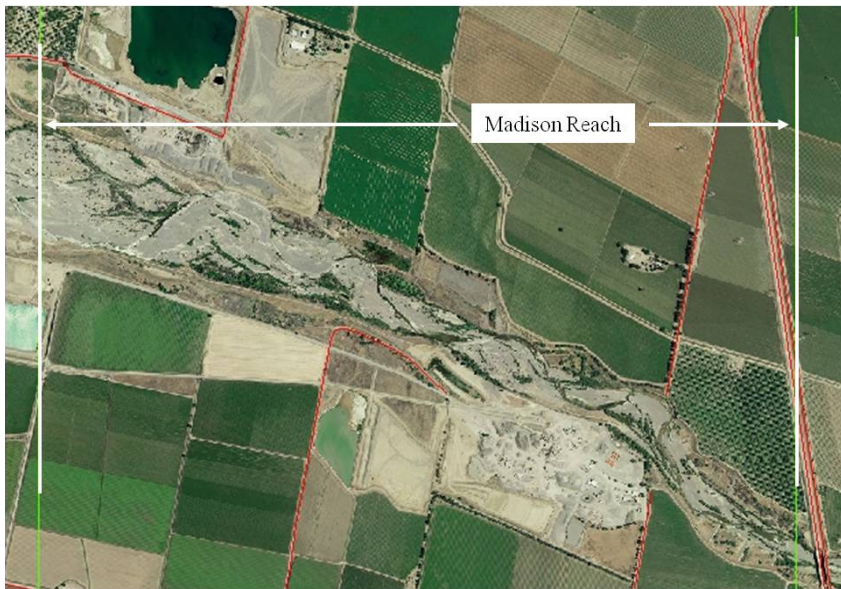
Figure 2.11 Aerial Photograph of Madison Reach

The Madison Reach starts at river mile 23.4. This reach is characterized as braided. Bank-full margins narrow considerably and the slope increases to 12.2 feet/mile (2.30 m/km) [12.4 ft/mi in 1995], with an average width of 802-feet (Figure 2.11).

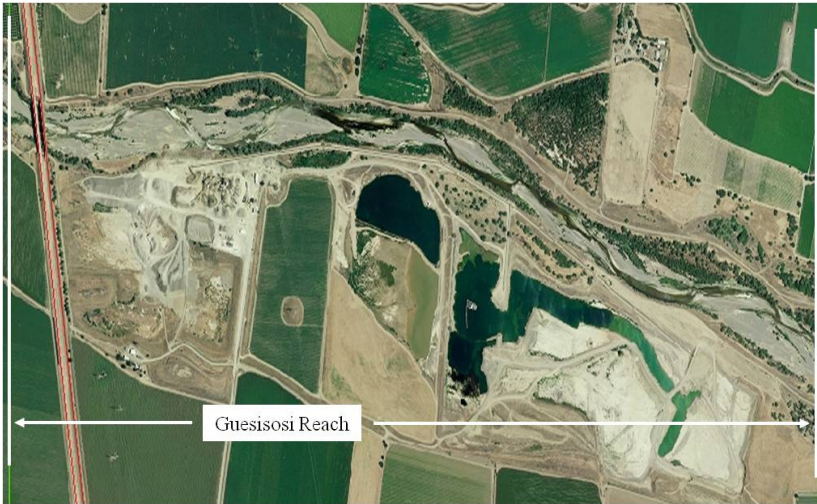
Figure 2.12 Aerial Photograph of Guesisosi Reach

The average slope decreases to approximately 7.6 feet/mile (1.44 m/km) [6.2 ft/mi in 1995] in the Guesisosi Reach, which begins at river mile 21.1 and has an average width of 375-feet (Figure 2.12, Tables 2.1, 2.2, Appendices A, B). Within this reach, the water table rises and allows some riparian vegetation to flourish (NHC, 1995). The Guesisosi Reach is fairly straight and is bordered on the south bank by artificial levees and the CEMEX aggregate operation.

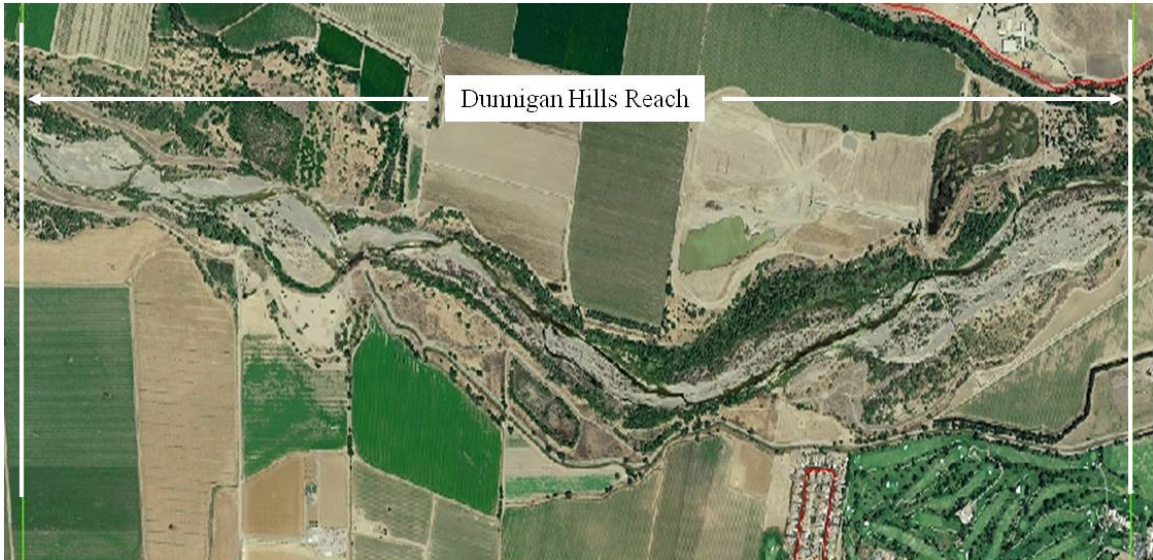
Figure 2.13 Aerial Photograph of Dunnigan Hills Reach

The Dunnigan Hill Reach starts at approximately river mile 18.9 and has just one active mine sites along its banks (Figure 2.13) (NHC, 1995).

Teichert Aggregates mined aggregate extensively along the north edge of the Dunnigan Hills Reach. High quality aggregate was extracted east of present day operations in this reach. After mineral reserves were exhausted in the 1990's, Teichert helped to reclaim the abandoned pit mine and donated the property to Yolo County. Today this piece of property is known as and managed by the Cache Creek Nature Preserve. The average slope within this reach is approximately 8.1 feet/mile (1.54 m/km) [9.9 ft/mi in 1995], and the reach is approximately 562-feet (171.3-m) in width (Tables 2.1, 2.2, Appendices A, B). This reach has a high water table year round (NHC, 1995). Due to the consistently high water table, the riparian vegetation is thick and can be found up to 1000-feet (~305-m) outside the bank-full margins.

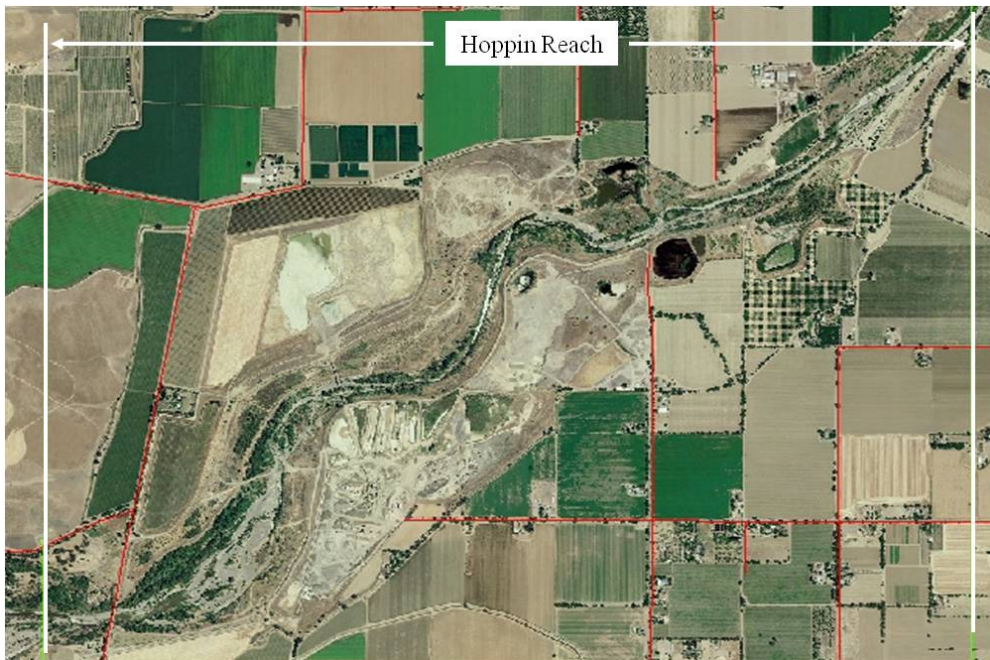
Figure 2.14 Aerial Photograph of Hoppin Reach

The Hoppin Reach begins just downstream of river mile 16.1, (Figure 2.14) (NHC, 1995).

The Teichert Woodland mine operation borders both the north and south banks within this reach. Areas of reclaimed riparian vegetation and naturally occurring vegetation can also be found along the channel. The average gradient here is approximately 8.0 feet/mile (1.52 m/km) [7.4 ft/mi in 1995] and has an average width of 500-feet (Tables 2.1, 2.2, Appendices A, B). The channel is initially sinuous, but straightens and narrows considerably downstream.

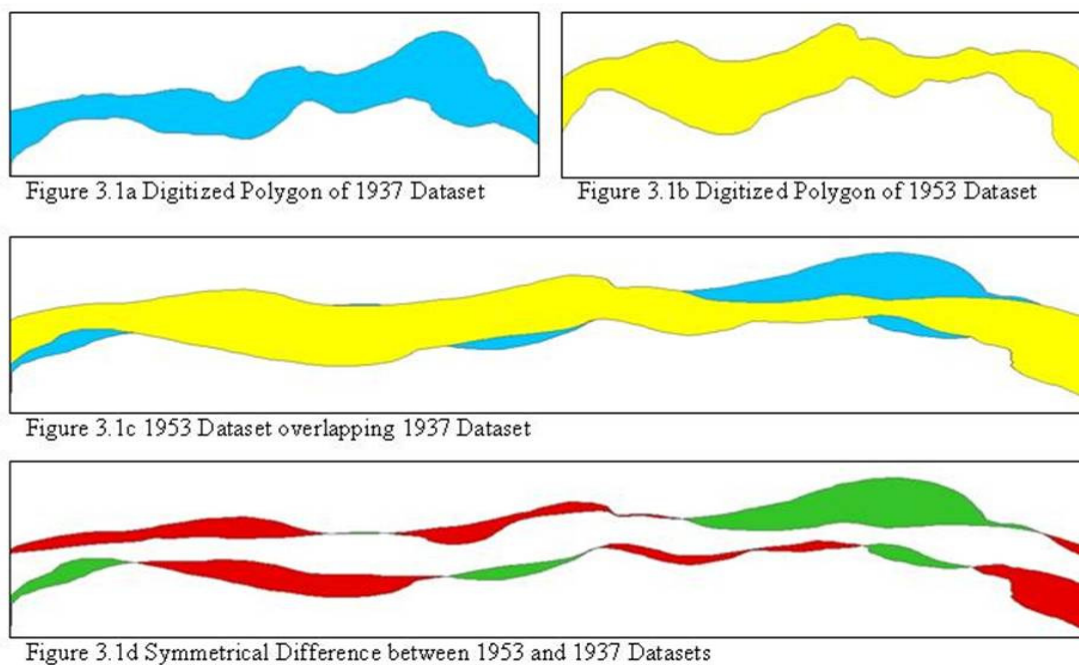
Figure 3.1a-d Example of GIS Symmetrical Differences

The symmetrical difference output files were converted to a new file separating the single erosion and single deposition polygons into individual polygons using the “multipart to singlepart” data management tool (Figure 3.1a-d).

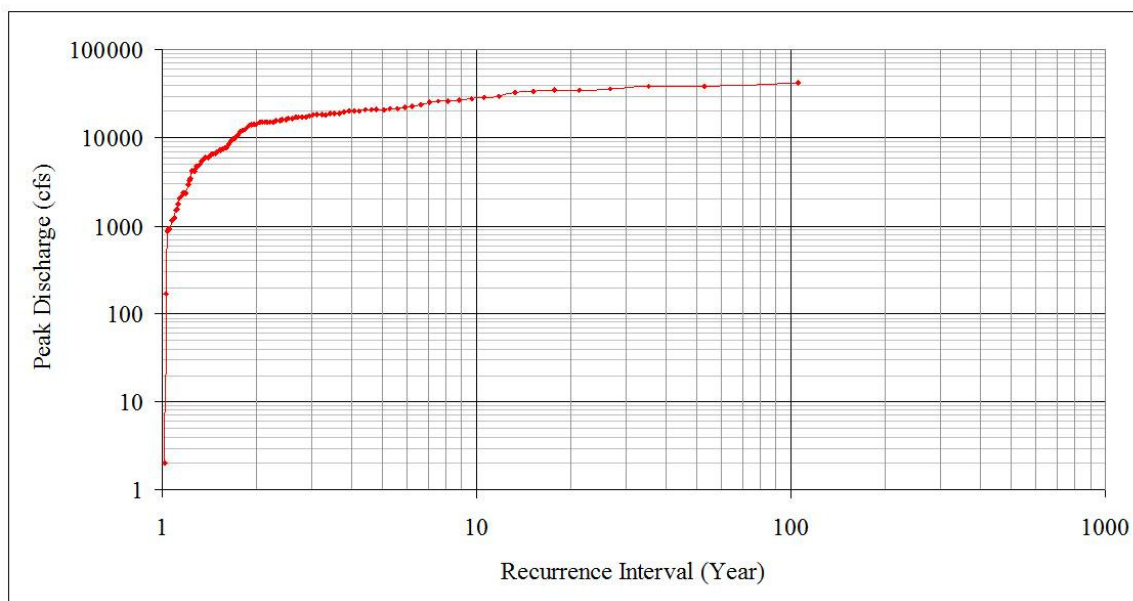
Figure 3.2 Recurrence Interval Curve for Yolo Gage #11452500

Peak annual stream flow was examined as a factor on channel migration for the eight photosets. Stream flow data were collected on Cache Creek at the USGS stream

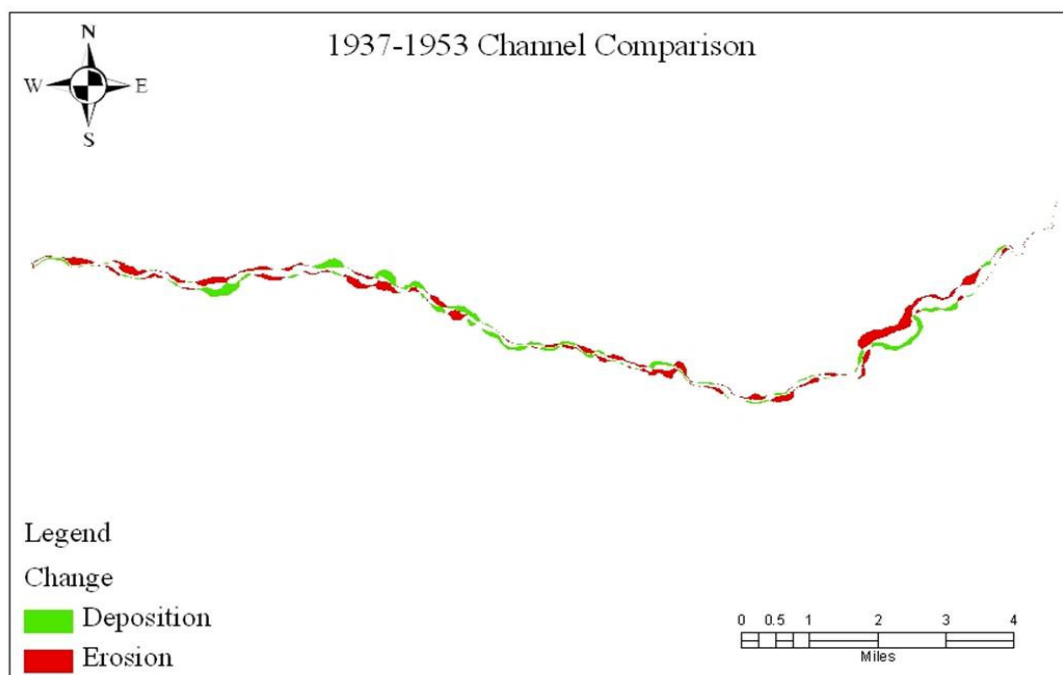
Figure 4.2 Channel Comparison Map 1937-1953

The 1937 to 1953 dataset comparison shows areas of significant channel migration. Lateral migration of the channel is significant along most of the channel (Figure 4.2).

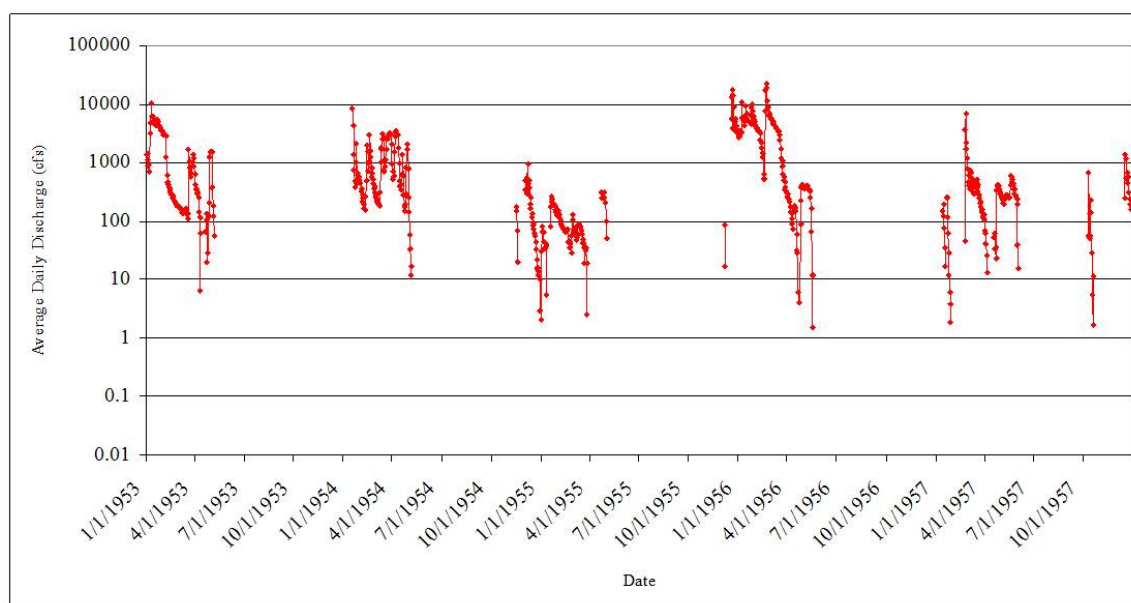
Mean daily flow data shows only two flood events measuring above 13,500 cfs (2-year flood frequency), with no other events recorded above a 23,500 cfs (5-year flood frequency) (Figure 4.5a-b). One long duration event was recorded between 1955 and 1956 with mean daily flows recorded above 2500 cfs for nearly two months.

Figure 4.5a Hydrograph of Average Daily Flow - Cache Creek at Yolo 1953-1957 (Linear Scale)

Figure 4.5b Hydrograph of Average Daily Flow - Cache Creek at Yolo 1953-1957 (Logarithmic Scale)

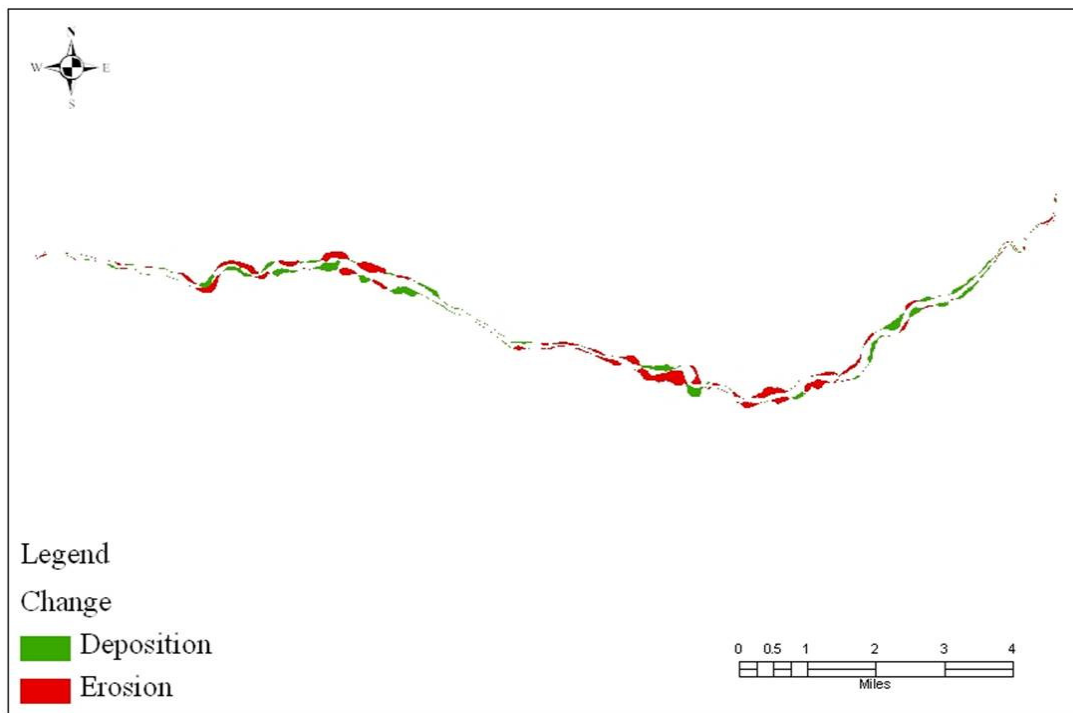
Figure 4.8 Channel Comparison Map 1964-1971

There is a large amount of channel migration between 1964 and 1971. There are areas with significant shifts in the channel and other areas where very little shift has occurred (Figure 4.8).

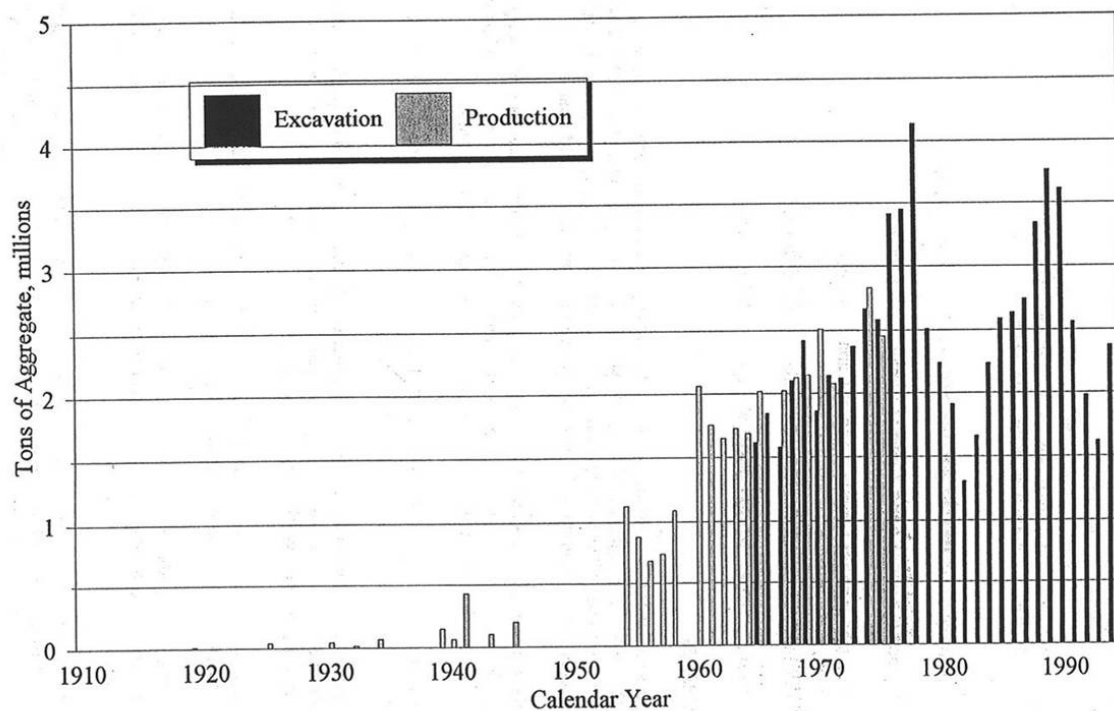
Figure 4.10 Cache Creek Aggregate Extraction/Production from 1919-1995 (NHC 1995 Technical Studies)

The 1964 to 1971 dataset has a large amount of affected land area (692.1 acres) and a high number of acres affected per year (86.5 acres/year) (Table 4.3d). The number three and number five highest ranked annual peak flows were recorded during this time (1964-1971). Similarly, there were a considerable number of moderate flow events lasting long periods of time. Aggregate excavation quantities ranged from 1.5 million tons to 2.5 million tons per year within the study area during this period (Figure 4.10). It is reasonable to conclude that long duration moderate mean daily flows, annual peak events, and mining contributed to the high amount of channel migration.

Aggregate production and excavation totals in Figure 4.10 show dramatic increases in excavation in the mid-late 1970 and again in the late 1980's and early 1990's. Comparing this information to results in Table 4.3, the main cause of limited channel migration from 1971 to 1996 is probably in-channel aggregate mining. Little channel migration occurred since mining went off channel in 1996. Two factors may be the cause of slight migration patterns after 1996. Earthen levee construction was required bordering mining operation sites to maintain 100-year flood protection, which may have

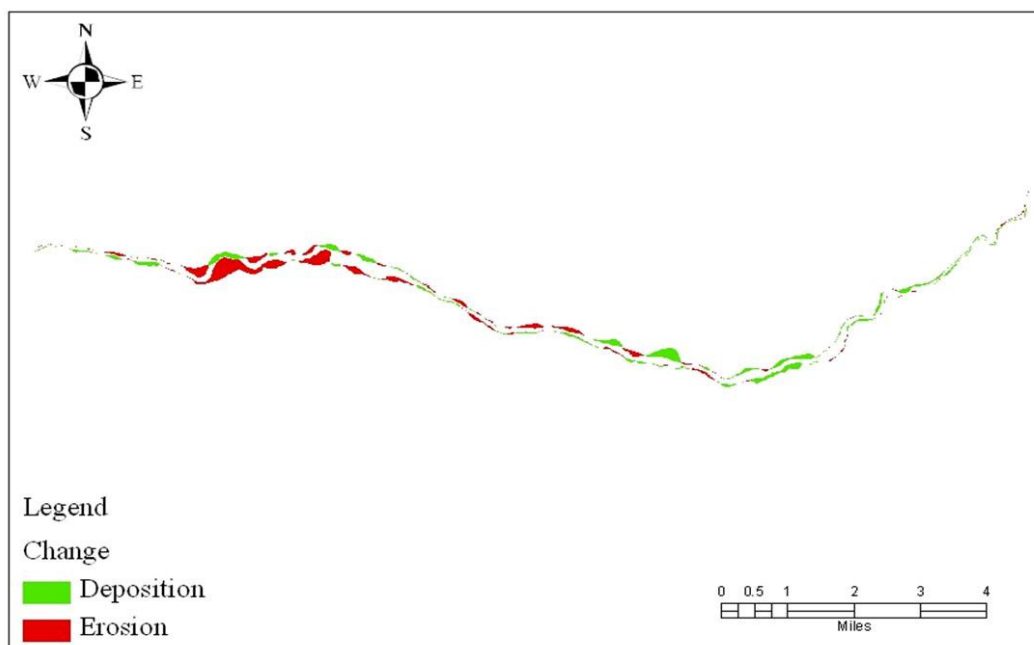
Figure 4.11 Channel Comparison Map 1971-1984

From 1971 to 1984, the upstream one-third of the study area shows large channel changes, mostly erosion, where the downstream two-thirds portion of the Cache Creek has smaller areas of migration (Figure 4.11).

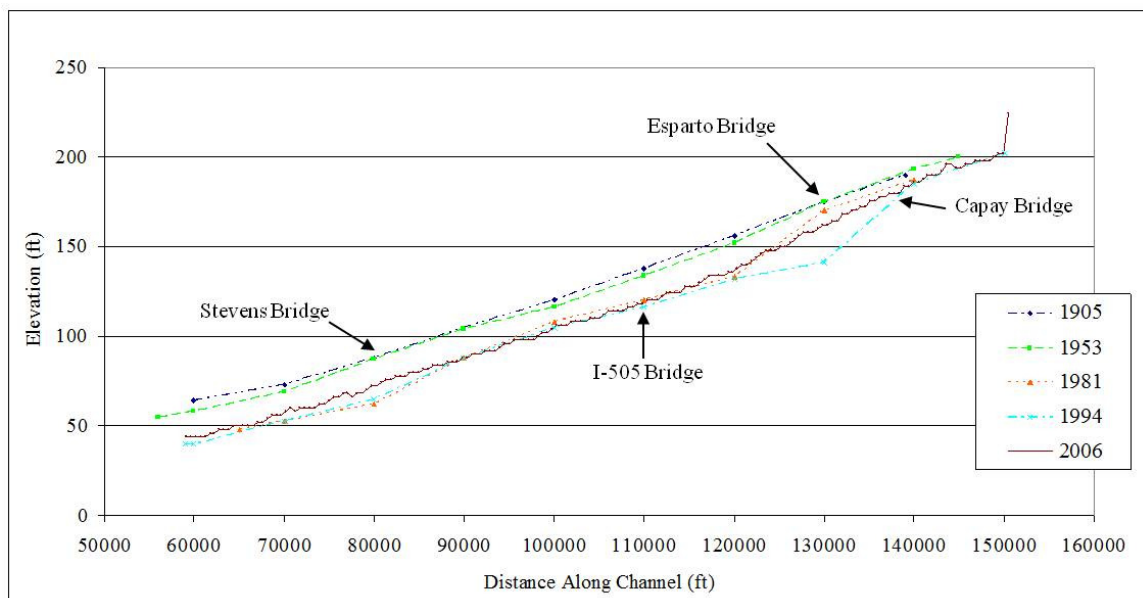
Figure 4.19 Graph of Longitudinal Profiles (Capay Dam to I-5 Overcrossing)

Longitudinal profiles from 1905, 1953, 1981, 1994, and 2006 were graphed in Microsoft Excel and elevations compared (Figure 4.19).

The elevation of the channel consistently decreases from 1905 to 1994. Significant decrease in elevation is noted between 1953 and 1981 along the entire study area. Between 1981 and 1994, the bed elevation was stable over most of the study area with the exception of the channel between river mile 22.6 and 26.4 (County Roads 88B and 85). During this period of time the greatest decrease in elevation is measured at the County Road 87 (Esparto) Bridge.

that in-channel aggregate mining was probably the main cause of channel incision in Cache Creek during this time (Figure 4.19).

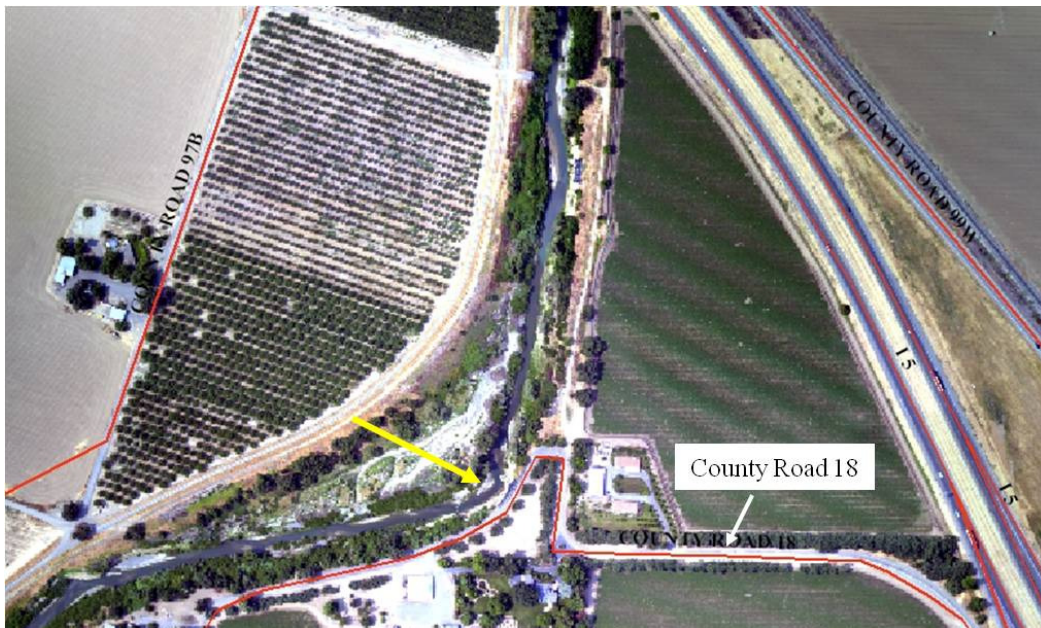
Figure 5.1 Aerial Photograph of Huff's Corner Location

Huff's Corner is located at the downstream portion of the study area near the Interstate 5 Overcrossing (Figure 5.1).

This area is of importance because County Road 18 was damaged in 2005 during a high flow event and emergency repair work was done, costing Yolo County millions of dollars. This area of the creek has migrated toward the southeast over the last twelve years. Lines were drawn representing bank full water levels for 1998, 2002, and 2006 to illustrate the migration of the creek (Figures 5.2a-e).

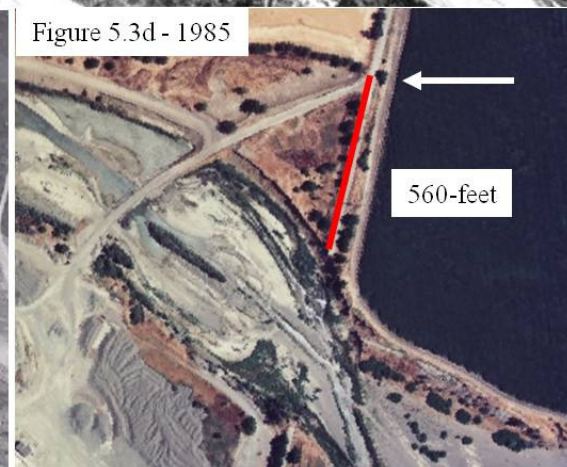
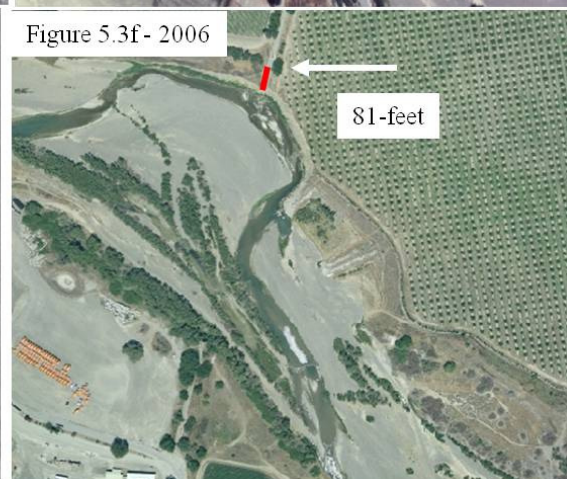
Figure 5.3a-f Aerial Photographs of County Road 89 in 1937, 1953, 1971, 1985, 1998, 2006

In 1978, the Madison Bridge that spanned Cache Creek on County Road 89 (CR89) collapsed. Although this bridge failure was not directly related to stream migration, it is speculated that stream migration was an indirect cause to its failure. Figures 5.3a-f are snapshots through time of the area surrounding the Madison Bridge from 1937 to 2006. All the photos are equal in size, scale, and position. The arrow in each photo points to the same reference position on the ground. A thick line was drawn from the reference point to the edge of the channel. There appears to be little change in the length of this line for the majority of the early photo sets. Figures 5.3b and 5.3c are images taken in 1952 and 1971 respectively. Large amounts of native vegetation were removed during this time along the north side of Cache Creek. The images in figures 5.3c (1971) and 5.3d (1985) show land originally classified as riparian converted to agricultural use. It is clear that in 1985 (Figure 5.3d) (7-years after bridge failure) the channel migrated to the north. Little change occurred between 1985 and 1998. From 1998 to 2006 the channel migrated significantly to the north, destroying private farm land and Pacific Gas and Electric (PG&E) power poles. Spur dikes were constructed sometime between 1998 and 2006 and are visible in the 2006 aerial photograph. This set of spur dikes is anchoring the downstream end of the meander.

If this meander bend continues to migrate to the north, there will be a continued loss of agricultural land (walnut orchard), and existing PG&E power poles will again be impacted.

Open riparian land has been converted to agricultural use closer and closer to the creek channel. This newly converted farm ground encroached on the natural flood plain of Cache Creek. This is evident in the aerial photographs in Figures 5.3a-f. Farmland bordering on Cache Creek and in the natural flood plain was and still is at risk for annual crop damage or possible permanent loss of farmable ground.

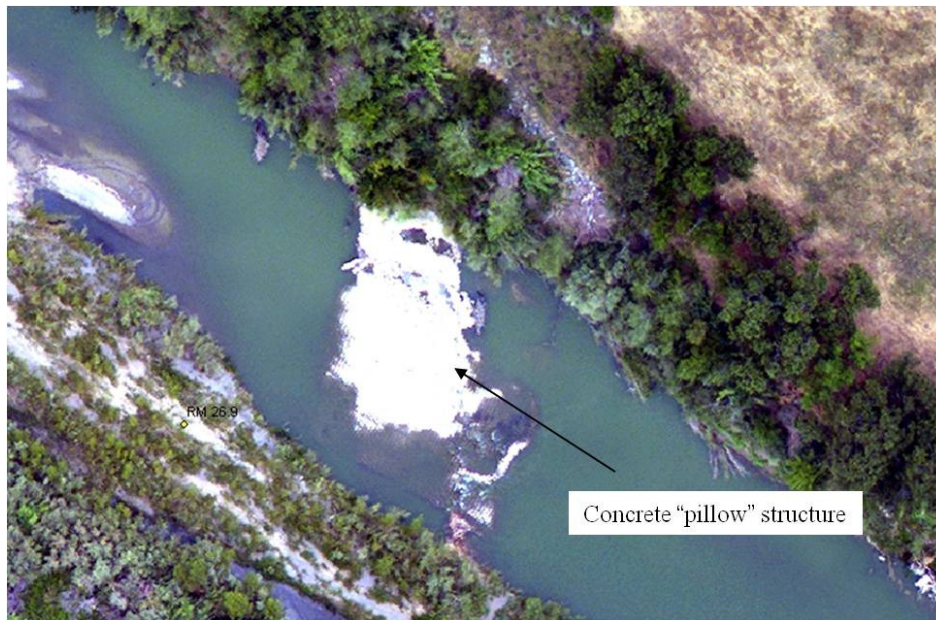
Figure 5.6 Aerial Photograph of Pacific Palisades – Concrete “Pillow” Structure Protecting PG&E Gas Pipeline (2006)

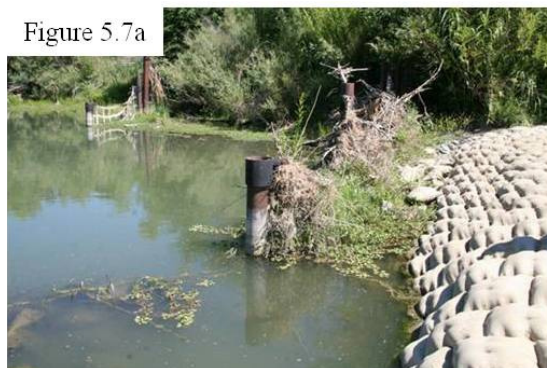
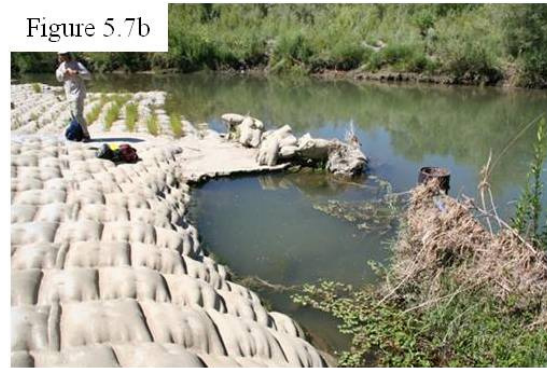
Figure 5.7a-b Photographs of Pacific Palisades Concrete “Pillow” Structure Protecting PG&E Gas Pipeline (Tim Horner, 2008)

Pacific Palisades is located in the Capay Reach at river mile 26.9 (Figure 5.6). Pacific Gas and Electric (PG&E) installed a natural gas pipeline which runs below Cache Creek at this site. Since the completion of this project, channel incision occurred exposing the Pacific Palisades pipeline. Repairs to protect the pipeline ensued. PG&E installed a mass of concrete “pillow” structures to prevent further incision of the channel at that site. Figures 5.7a-b show significant damage to the concrete pillow structure where scouring occurred, exposing the pipeline a second time. No repair work has occurred to date. PG&E has spent large amounts of money to install and protect the Pacific Palisades pipeline and more will be spent to protect this infrastructure.

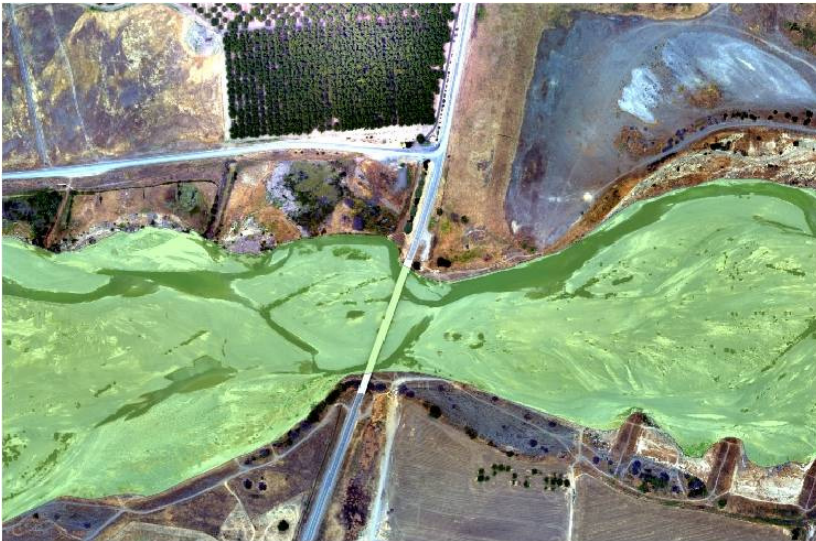
Figure 6.1b Narrow Channel at CR 87 Bridge (2006)

Bridges have been built and rebuilt over the last century and the channel has narrowed significantly at locations along each creek overcrossing (Figure 6.1a-b). Channel narrowing can cause scouring at bridge supports that may contribute to bridge weaknesses or failure.
