**Physical and geochemical characteristics of the Lower Sailor Bar 2012, Upper Sunrise 2010/2011, Upper Sailor Bar 2009, and Upper Sailor Bar 2008 gravel additions**

Submitted to the US Bureau of Reclamation, Sacramento office

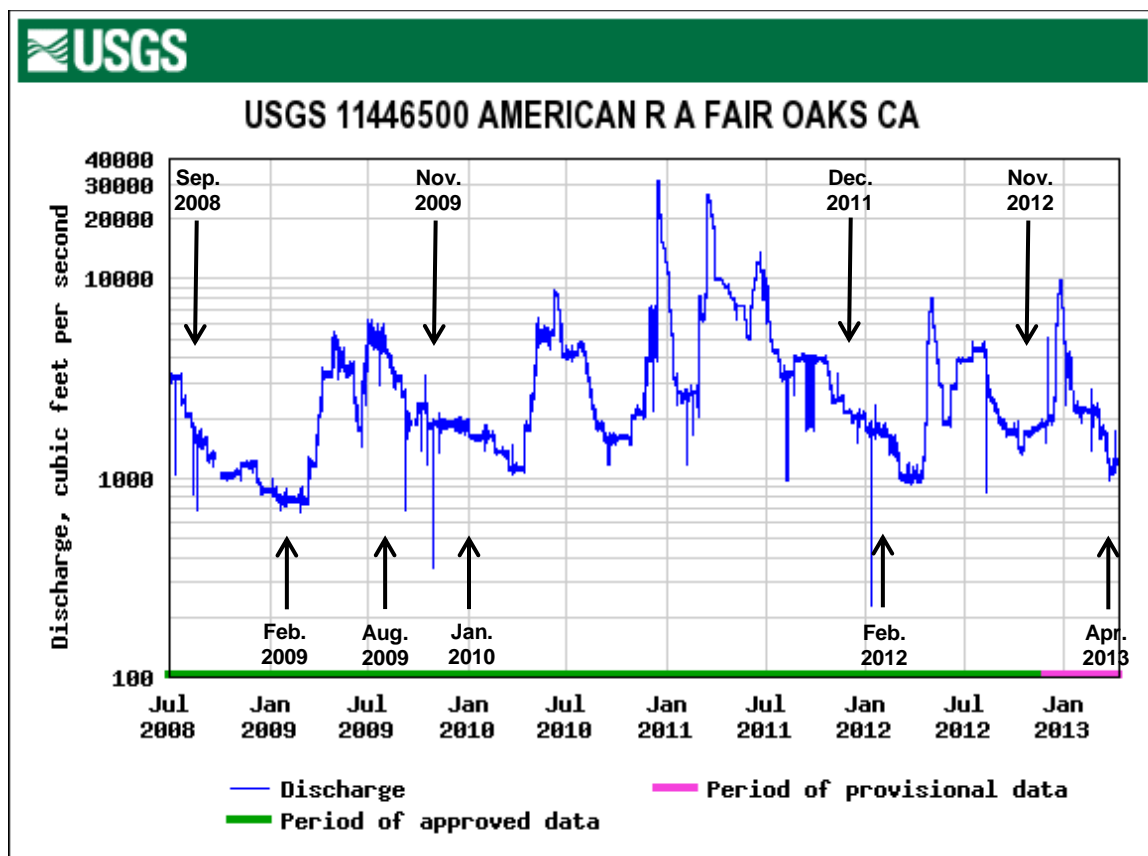
**Figure 1.5:** Lower American River Peak Discharge from July 2008 through April 2013 (From the USGS, 2012). Black arrows indicate months when water quality parameter data were collected.

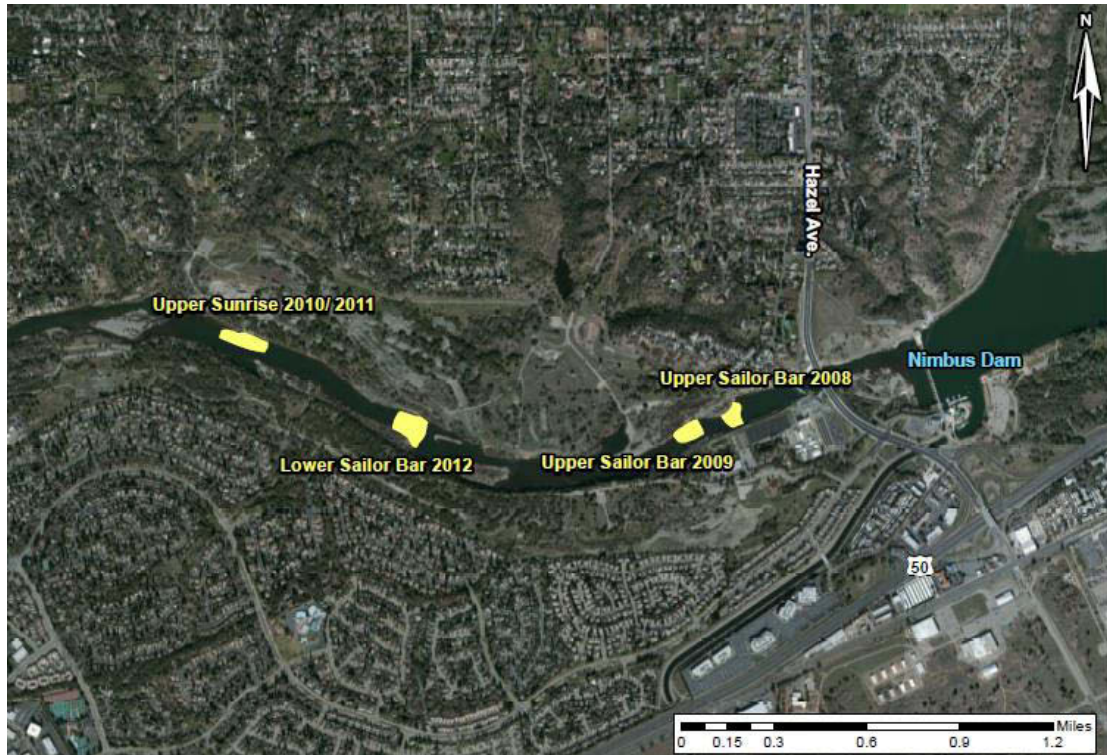
**Figure 1.6:** Location of four restoration sites on the Lower American River. Nimbus Dam obstructs the passage of fish further upstream.

In 2008, a new phase of remediation began with augmentation of 7,000 tons of gravel at the Upper Sailor Bar 2008 study site (Figure 1.6), followed by five years of post-treatment monitoring and evaluation. The succeeding year, Upper Sailor Bar 2009 was augmented with 9,000 tons of gravel and has been monitored for the past four years. 12,000 and 14,000 tons of gravel were added to the Upper Sunrise 2010/2011 site in 2010 and 2011, respectively, with monitoring through 2013. Finally in September of 2012, approximately 14,000 tons of gravel was added to the Lower Sailor Bar 2012 site (Figure 1.7), followed by post-treatment monitoring and analysis in 2012 and 2013.

This project used a BACI study design (“Before, After, Control, Impact”) to show differences between gravel areas before and after restoration (Horner et al., 2004). Faculty and students from CSUS focused on physical and hydrologic measurements at four gravel addition sites (Figure 1.6) from 2008 through 2013. Measurements included grain size analysis, gravel mobility, surface water depth and velocity, gravel permeability, hyporheic pressure head, temperature, and inter-gravel water quality parameters.

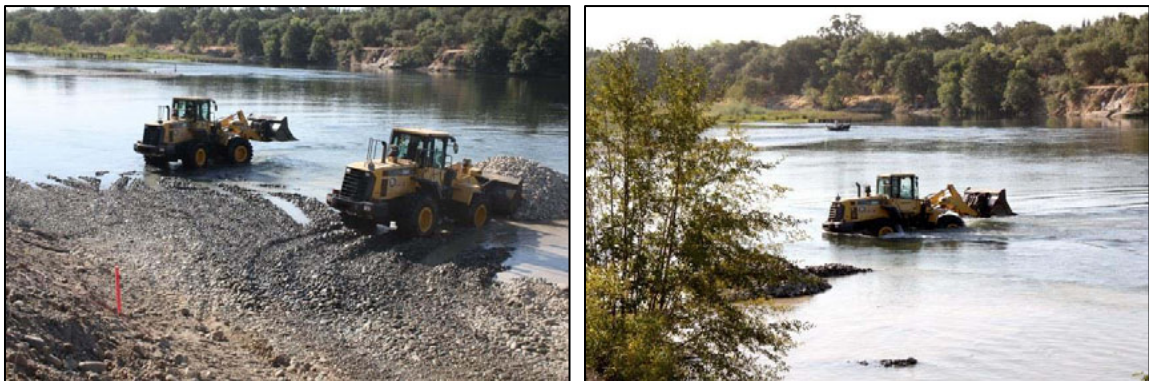
**Figure 1.7:** Komatsu front-end loaders placing sorted gravel across the Lower Sailor Bar 2012 gravel restoration site in September 2012 (From BOR, 2012)

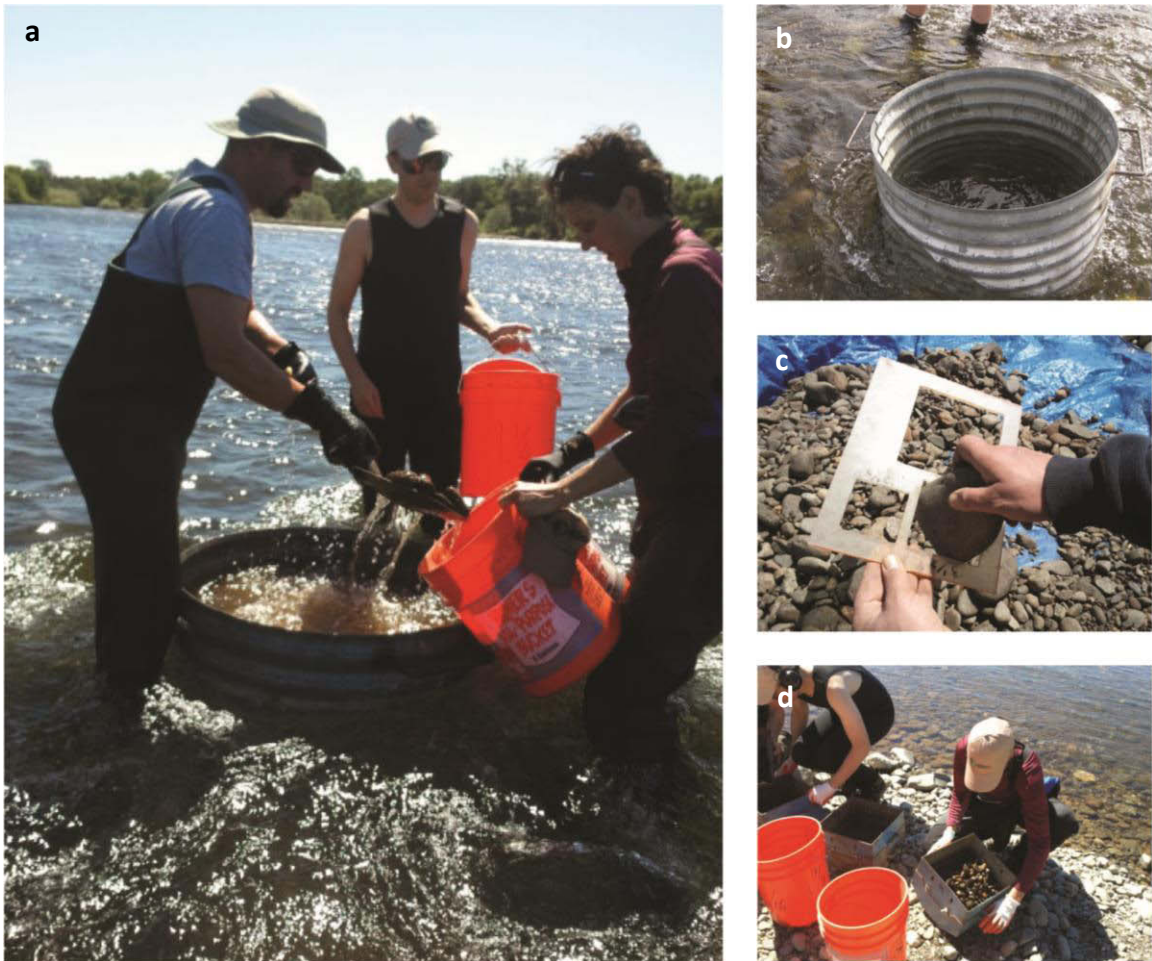
**Figure 2.3:** Bulk samples are (a) collected and transported to shore in 5 gallon buckets. (b) A metal baffle prevents fines from escaping during collection. (c) A pebble size template with square openings measures the intermediate axis diameter of grains; the largest opening through which the grain will not fit is considered the upper end of the grain size range. (d) Grains are sorted into size classes using rocker sieves.

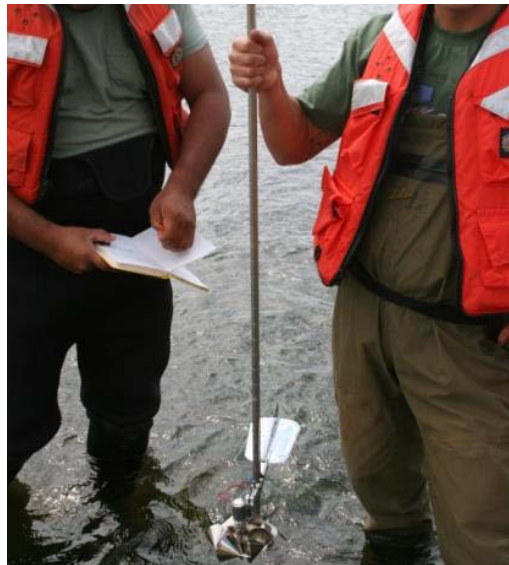
**Figure 2.8:** Field team determining surface water depth and velocity using a wading rod and Price AA current meter.

Depth and velocity were measured at all four restoration site using standard USGS stream gaging procedures (1980). A topset wading rod was used to determine depth. A Price AA current meter or a Marsh-McBirney electronic velocity meter was attached to the wading rod to measure surface water velocities (Figure 2.8). Measurements were made at locations where mini-piezometers had been installed throughout the study area. When using the current meter, the number of revolutions (R) completed by current meter cups was counted for a 60 second interval, and then converted to velocity (V) using equation 2.2 (USGS, 1980).

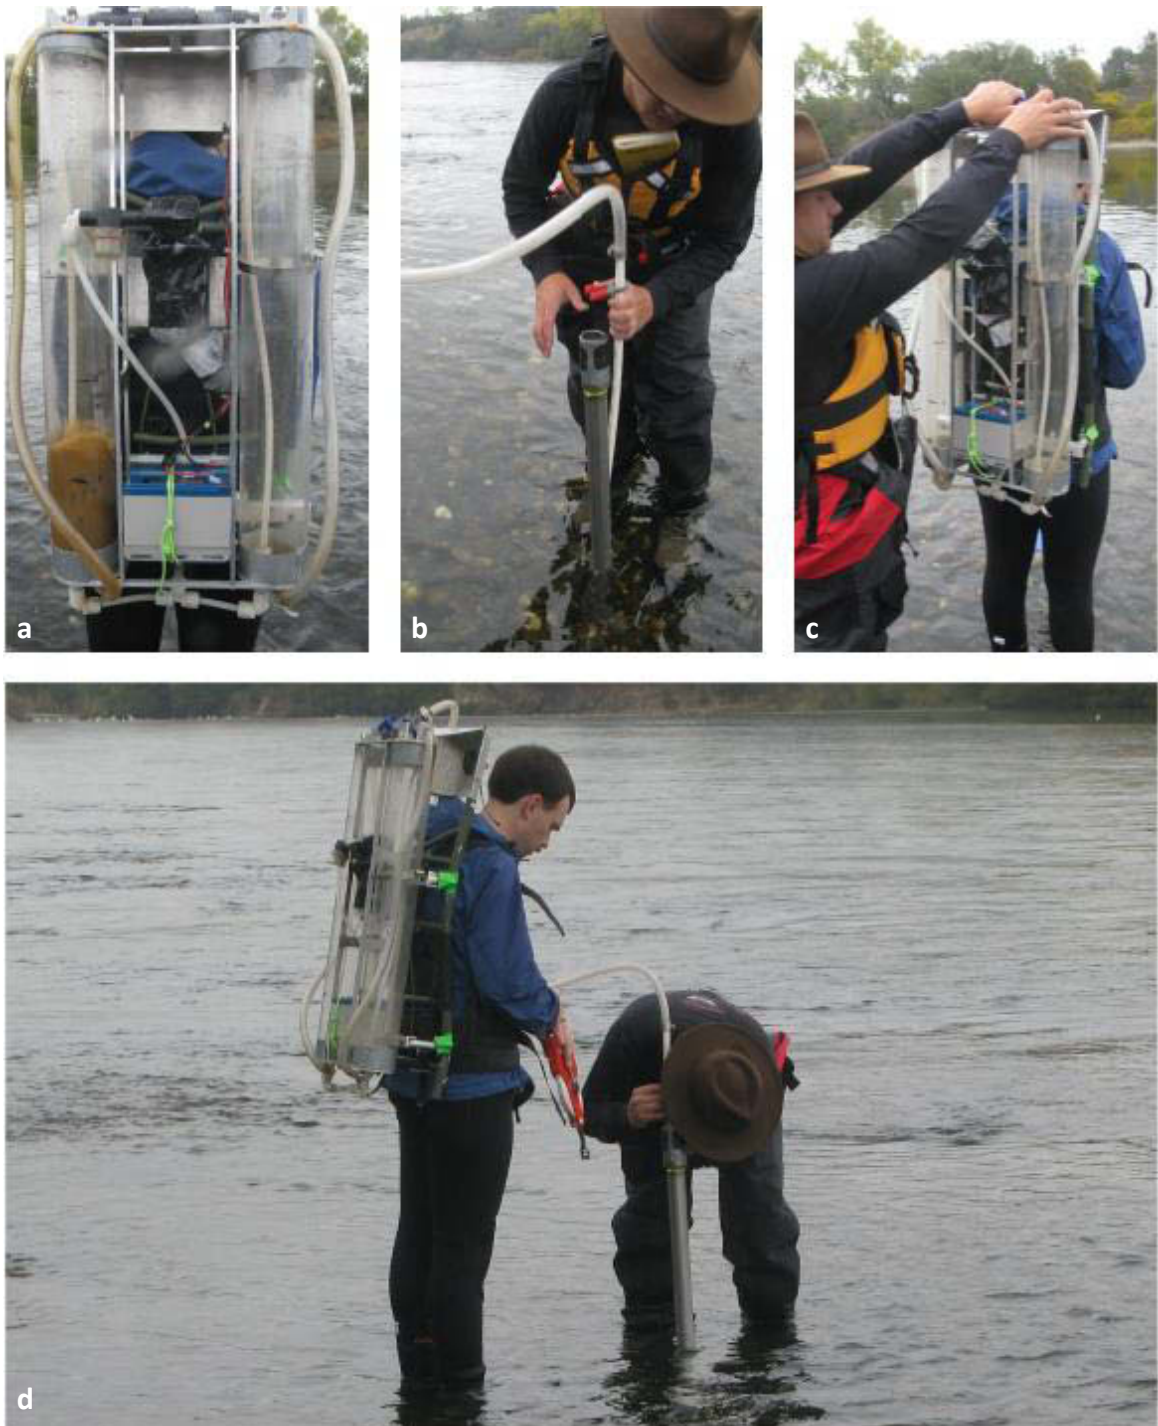
**Figure 2.10:** Drawdown testing uses a pumping apparatus (a) with two capture tanks. An extraction hose is inserted into the standpipe (b) one inch below the water level. The field team determined the water level in the pipe by listening for a “slurping” sound (d) that indicated the end of the hose had made contact with the water. When drawdown was achieved, the main capture tank was opened to collect the sample (c).

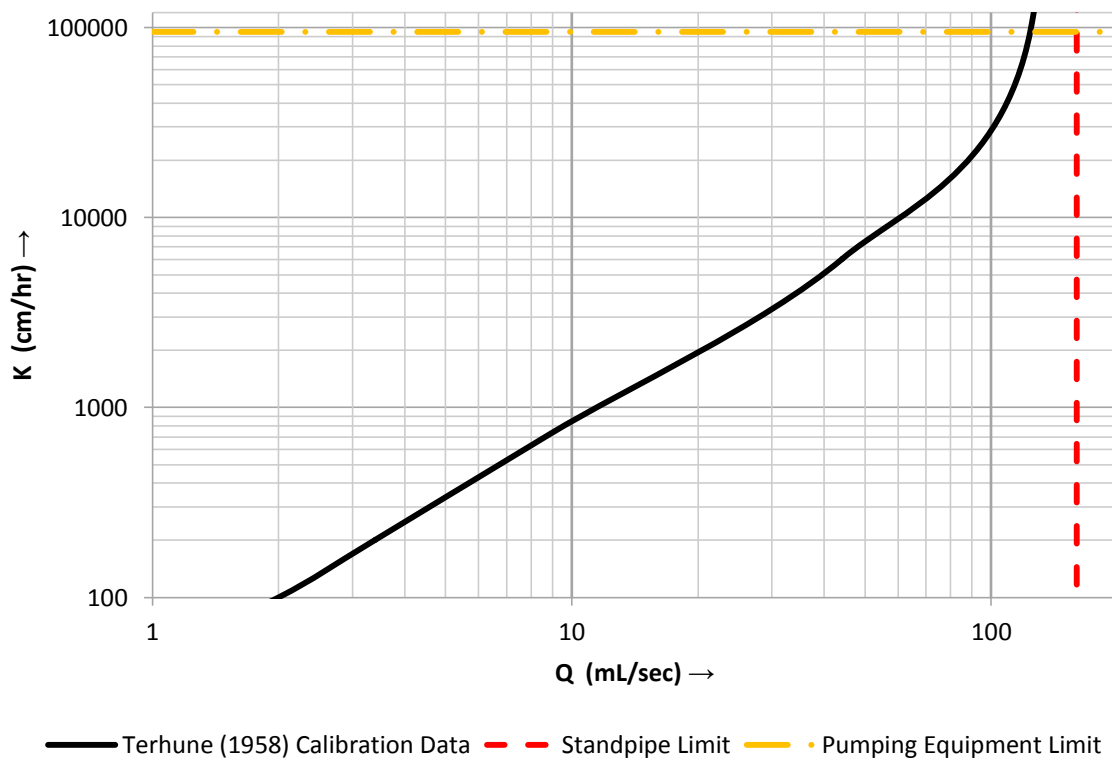
**Figure 2.11:** Modified Terhune (1958) calibration chart; Standpipe limit is 160 mL/sec (Terhune, 1958); Pumping equipment limit is approximately  $9.5 \times 10^4$  cm/hr or 124 mL/sec.

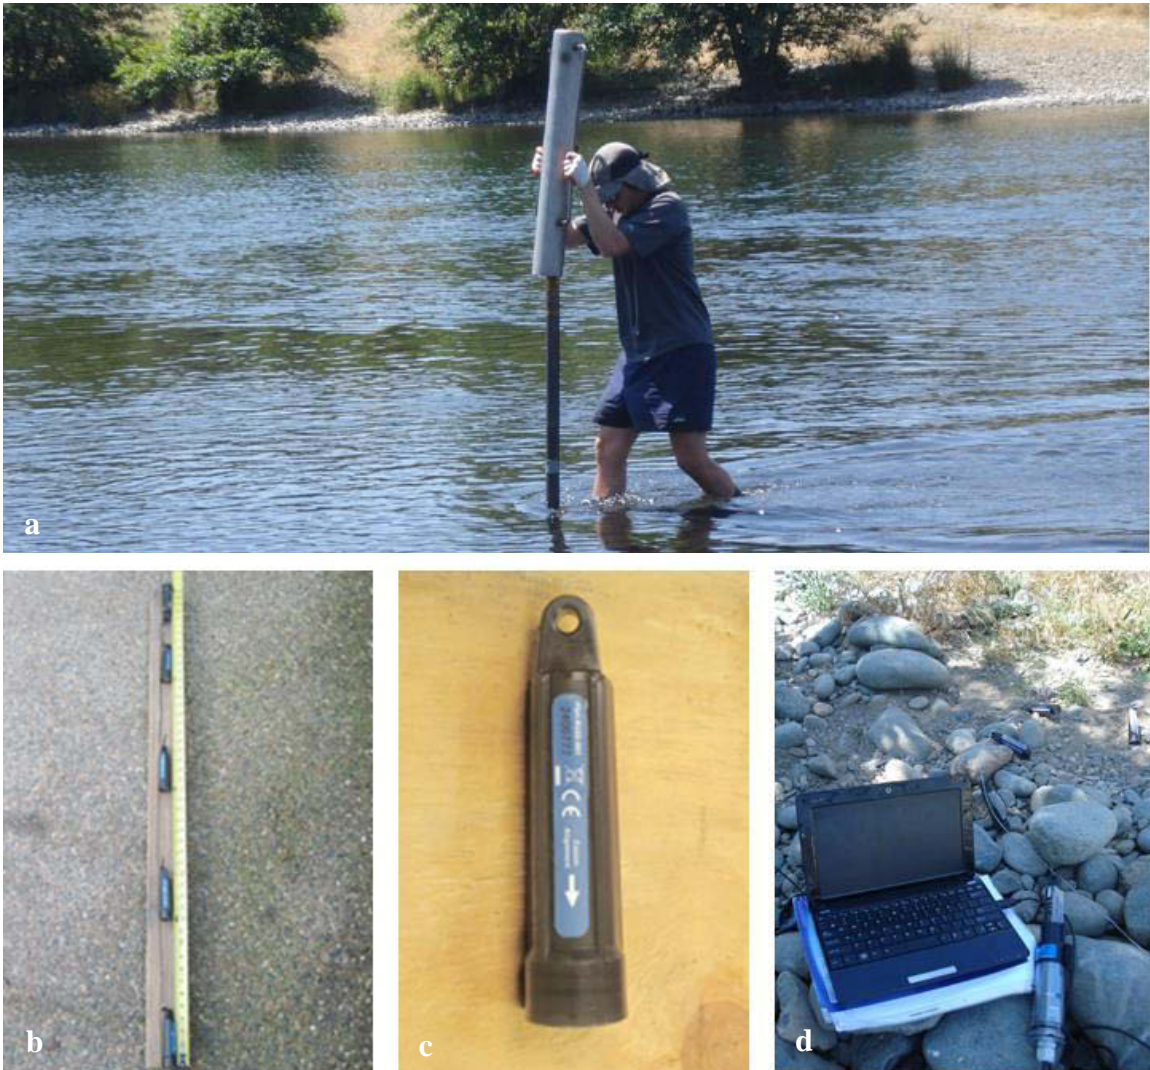
**Figure 2.15:** A string of (c) Hobo water Temp Pro v2 data loggers are affixed at (b) 0 foot (gravel river interface), 1 foot, 2 foot, 3 foot, 4 foot intervals and inserted into the streambed using a (a) sleeve assembly and post driver. Data is retrieved by (d) connecting each logger to a computer and uploading information.

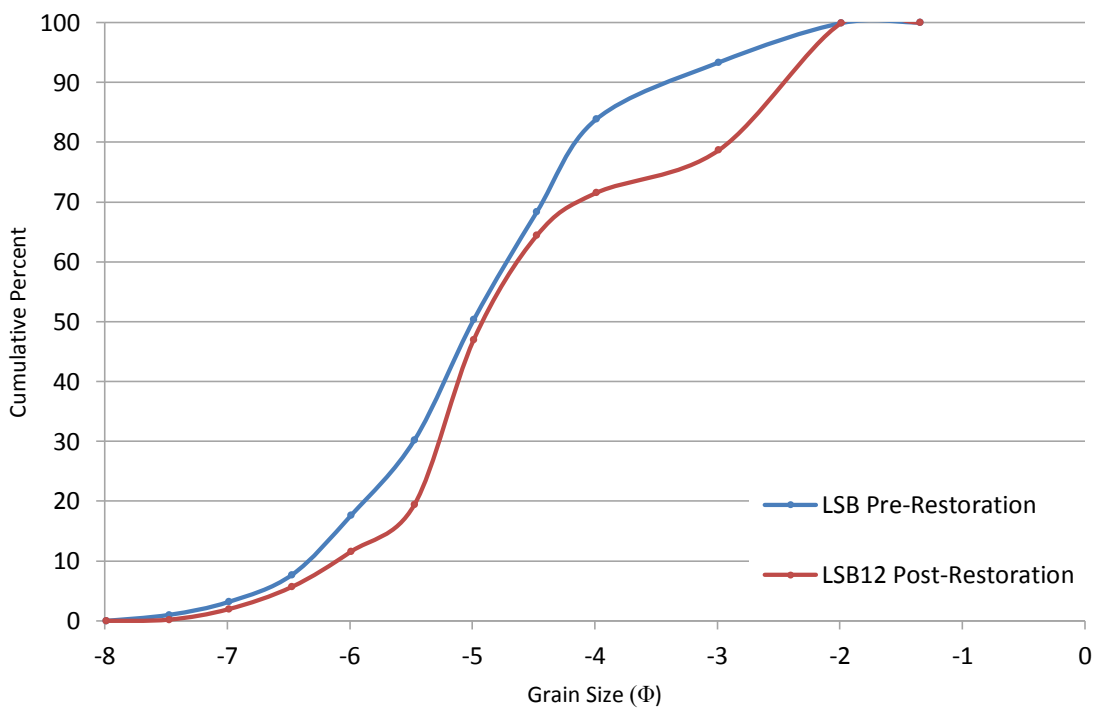
**Figure 3.6:** Pebble count averages at Lower Sailor Bar 2012 before and after restoration.

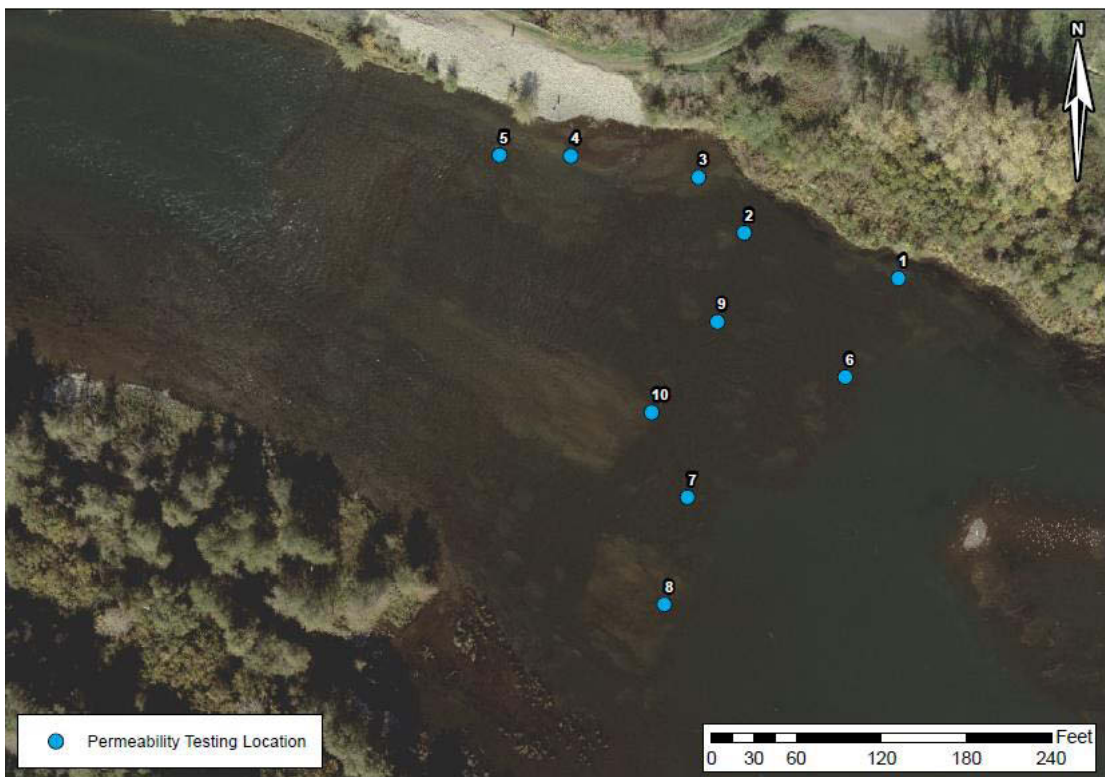
**Figure 3.14:** Location of permeability tests at the Lower Sailor Bar 2012 site.

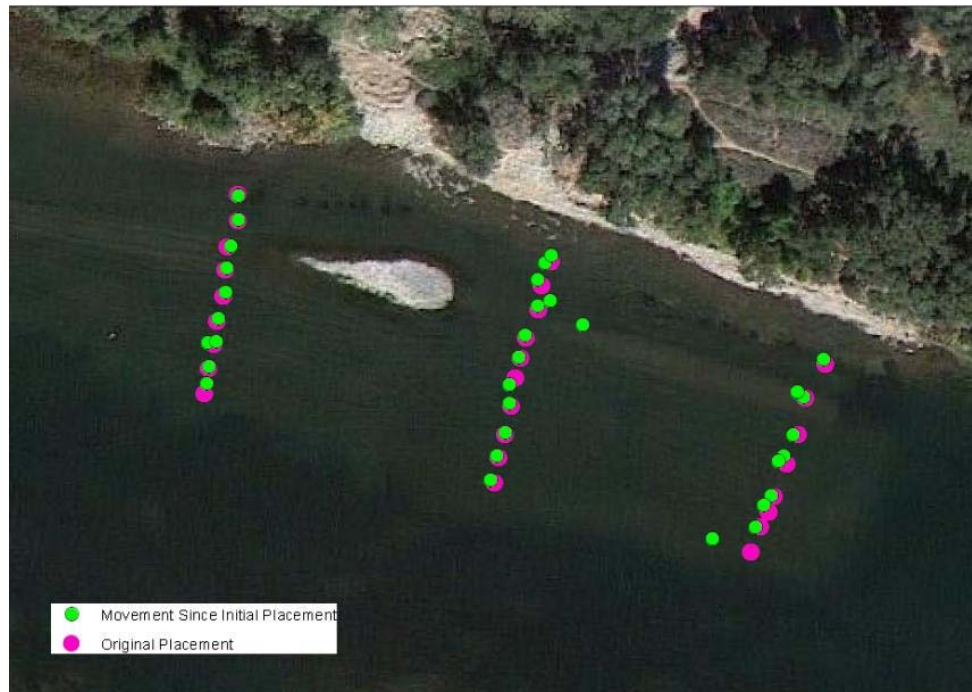
**Figure 4.1:** Post gravel addition map of Upper Sunrise 2010/2011 showing initial placement of tracer rocks (pink) and location of rocks located in May 2012 (green). Large (2.5 in. - 3 in.), medium (1.25 in. - 1.75 in.), and small (0.625 in. - 0.875 in.) tracer rocks were placed at each point on the map.

Tracer rocks were deployed at the study site immediately following gravel augmentation in 2011 and positions tracked in 2012 and 2013. As of May 2012, the majority of tracer rocks had moved no more than 10's of cm downstream of initial placement (Figure 4.1). Tracer rocks were located again in April 2013 following the Winter season. River flows between October 2012 and April 2013 ranged from a low of 942 cfs to a high of 9,980 cfs with a mean flow of 2,382 cfs. Flows above 5,000 cfs persisted throughout the month of December. As of April 2013, tracer rocks showed little to no additional movement.

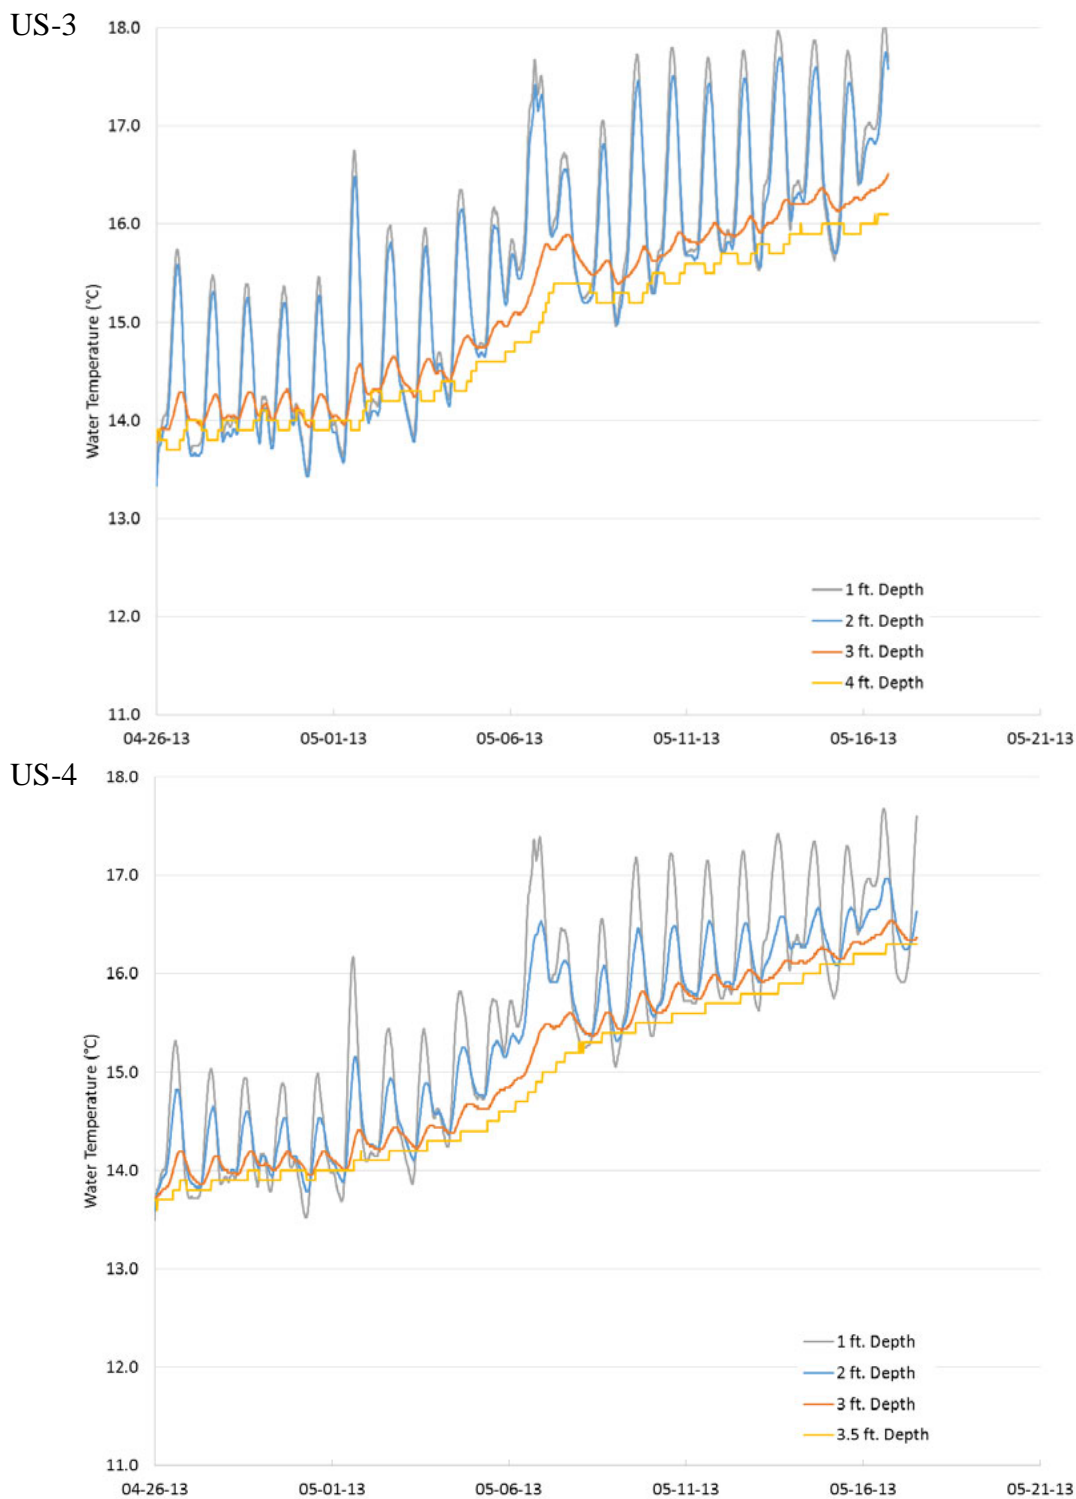
**Figure 4.8b:** Water temperature at the Upper Sunrise 2010/2011 site. US-3 and US-4 were located downstream and show less heat exchange below 2 ft depth in the gravel. This may indicate upwelling conditions or denser impermeable substrate.

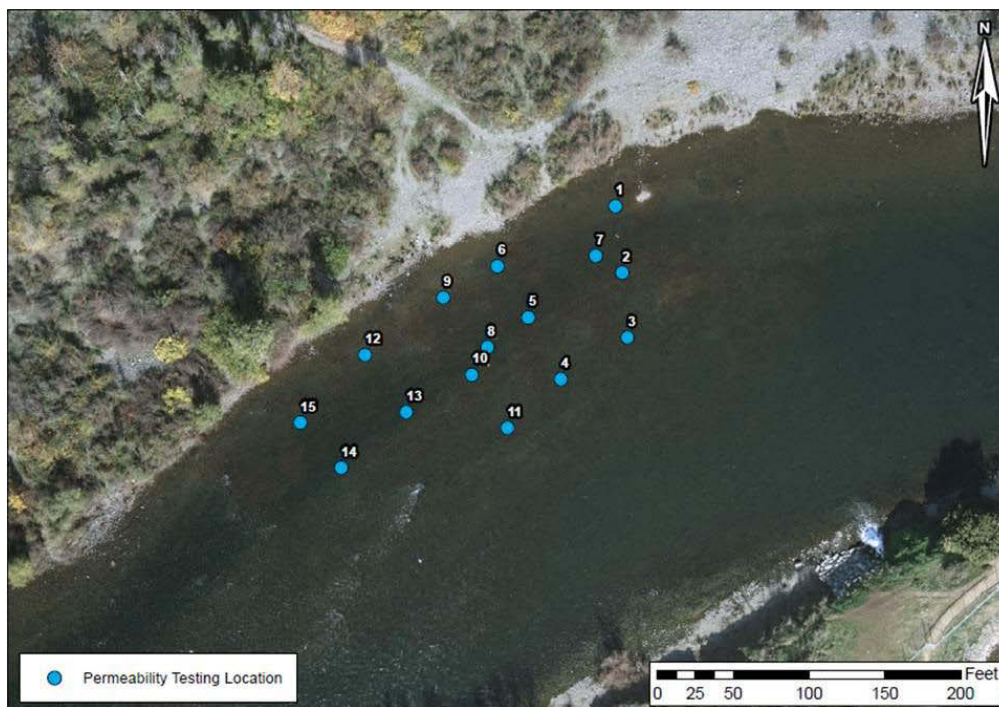
**Figure 5.2:** Locations of permeability tests at the Upper Sailor Bar 2009 site.

Between January and February 2013, 16 permeability tests were conducted at the site. River flows averaged 2,300 cfs during testing (Figure 5.2). Nine successful tests produced a wide range of hydraulic conductivity values ranging from 500 cm/hr to 19,000 cm/hr and a coefficient of variation of 83 (Table 5.4). Permeability exceeded

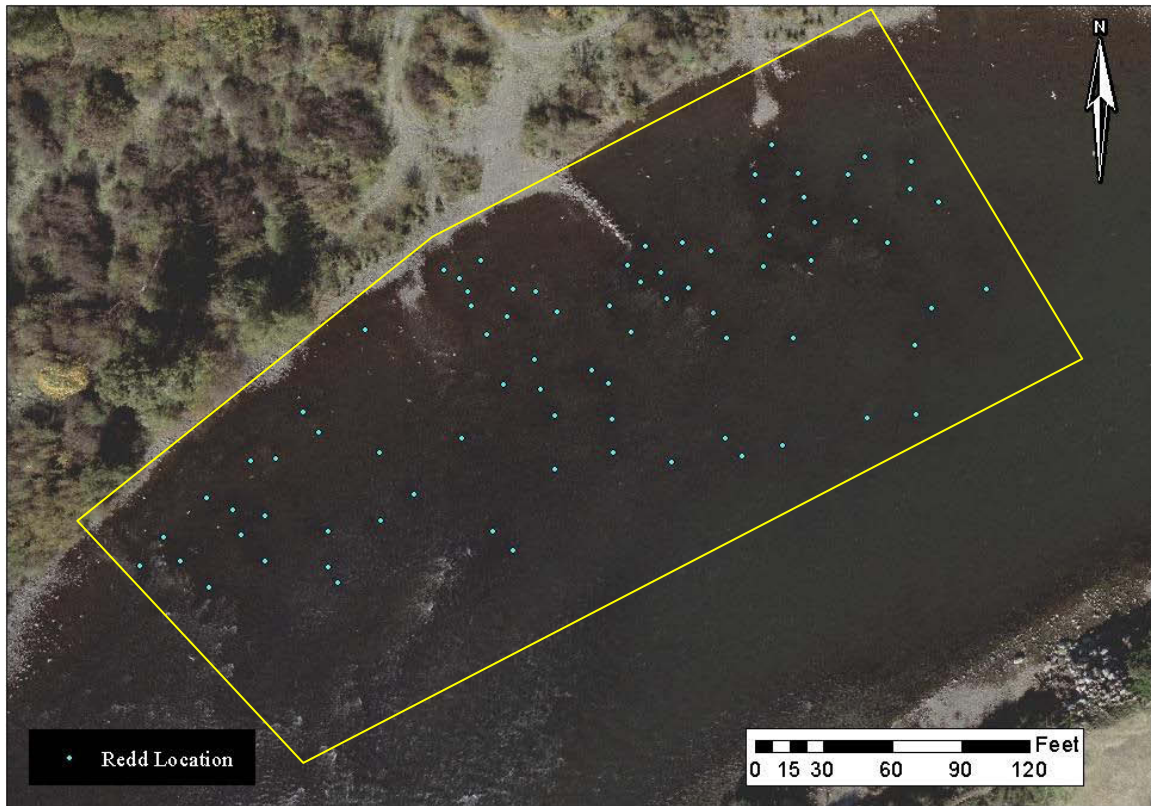
**Figure 5.7:** Fall-run Chinook salmon redd locations at the Upper Sailor Bar 2009 site during the 2012 spawning season. 63 redds were counted from photos of the site as of November 26, 2012. Redd counts may be underestimated, because shadows or substrate conditions may prevent detection of all redd locations from aerial photos. Yellow line indicates augmentation boundary. (High resolution aerial images courtesy of John Hannon, USBOR)

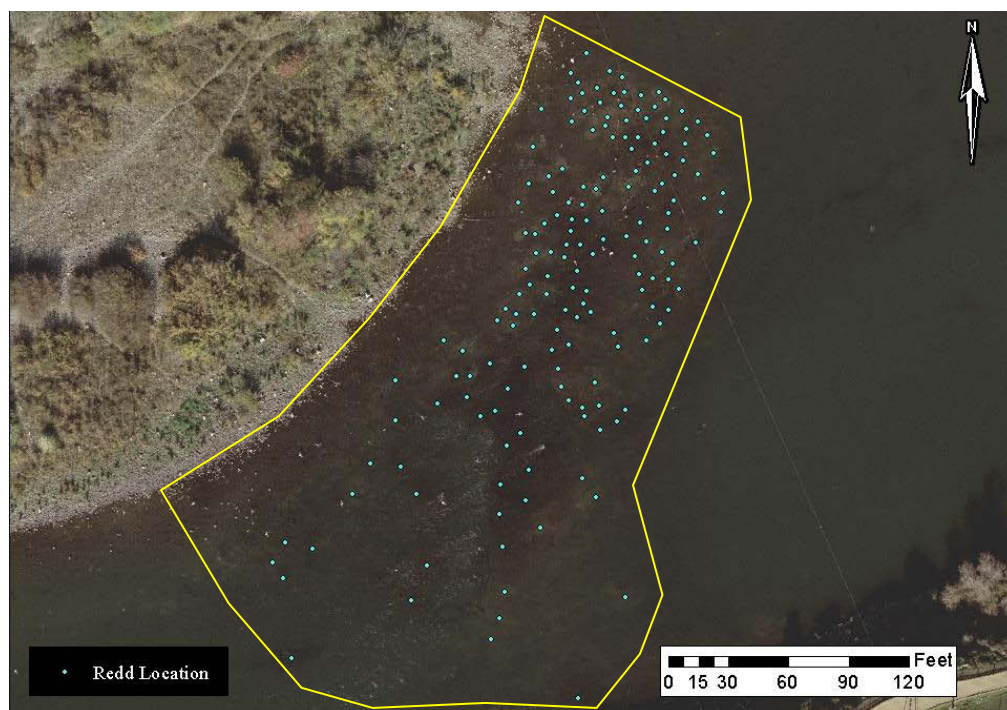
**Figure 6.9:** Fall-run Chinook salmon redd locations at Upper Sailor Bar 2008 during the 2012 spawning season. 166 redds were counted on November 26, 2012. Redd counts are inexact, because shadows or substrate conditions may prevent detection of all redd locations from aerial photos. The yellow line is the augmentation boundary for the site. (High-resolution aerial images courtesy of John Hannon, USBOR)
