Physical and geochemical characteristics of the 2008 Sailor Bar gravel addition

Submitted to the US Bureau of Reclamation, Sacramento office

Tim Horner
Professor, CSUS Geology Department

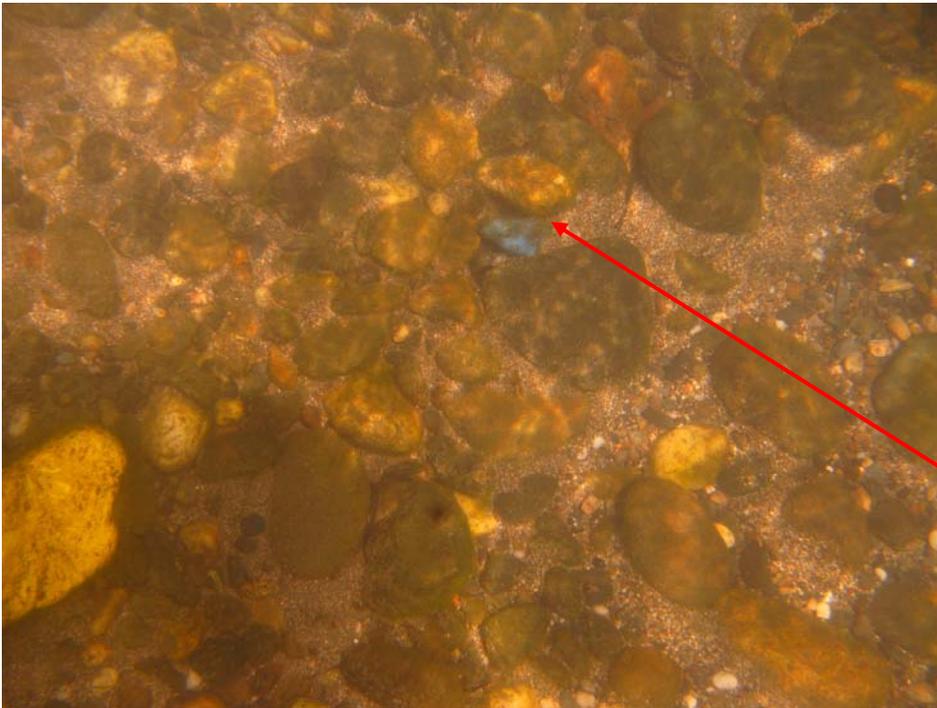
The tracer rocks were placed in transects across the new gravel addition at upstream, mid gravel addition, and downstream locations. The largest rocks (2 ½-3 inch) were painted bright yellow, the medium size rocks (1 ¼ to 1 ¾ inch) were painted blue, and the smallest rocks (5/8- 7/8 inch) were painted red for obvious differentiation from the riverbed. The transect lines were mapped with high resolution GPS to within 50cm horizontal error. The tracer rocks were initially deployed at a flow of 800 cfs. Figures 1 and 2 show pictures of a grouping of the two largest grain sizes used in the tracer rock study.

Figure 1: Picture showing the two largest grain sizes used in the tracer rock study.

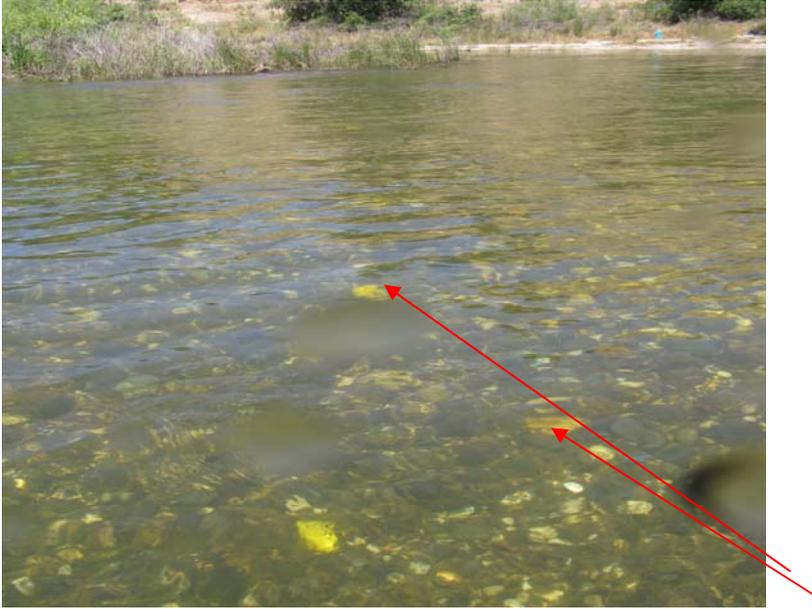
Figure 2: Arrows are pointing to yellow and blue tracer rocks.

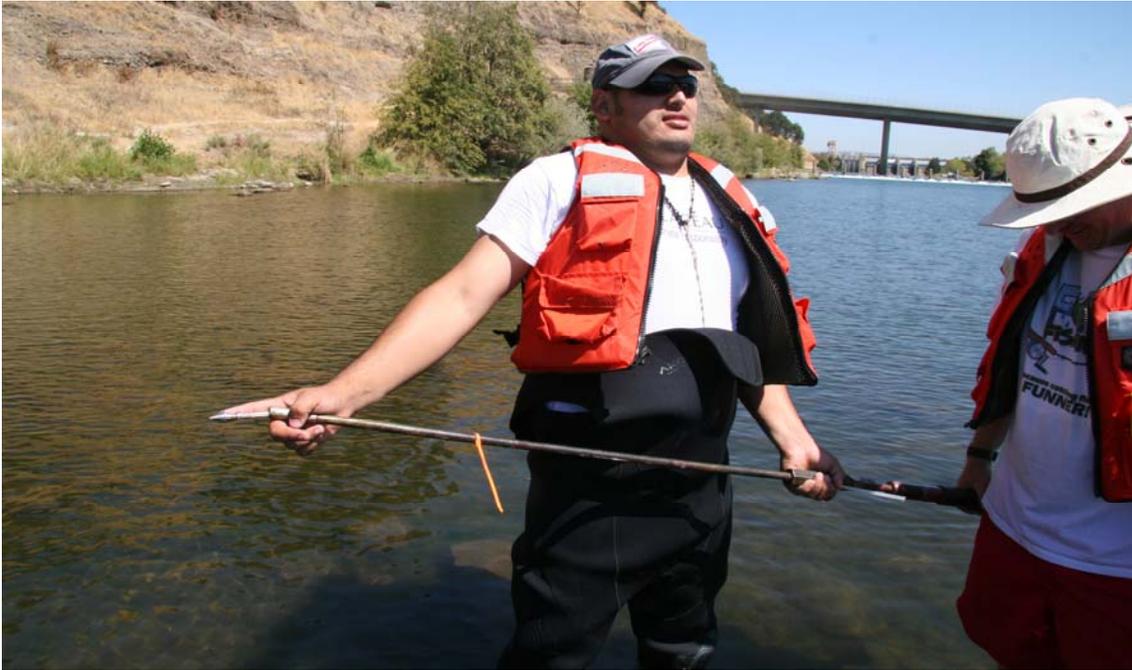
This study design is known as a BACI study design, where sites are evaluated Before, After, Control, and Impact of the restoration area. Figure 3 shows the piezometer tip with polyethylene tubing.

Figure 3: Picture of the piezometer tip and $\frac{1}{4}$ inch tubing used for mini piezometers. The mini piezometer is inside of the drive rod device used for mini piezometer installation.

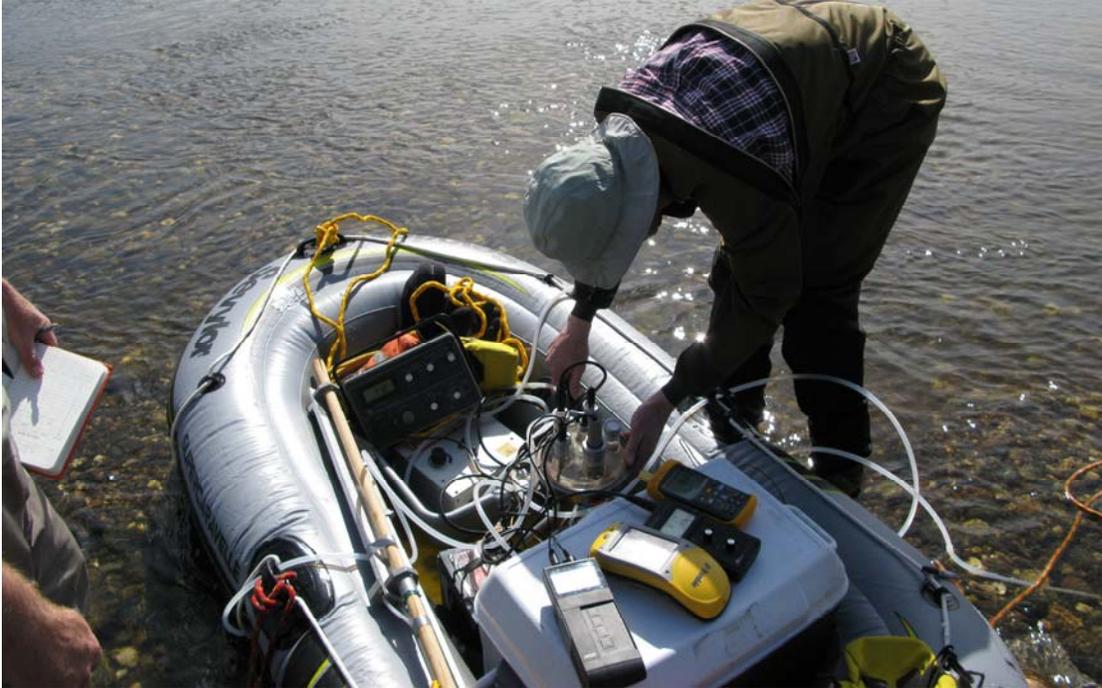
Figure 4: Picture of the field setup for the flow-through cell and water quality equipment.

During hyporheic sampling events, water was pumped from the piezometers into a sealed flow-through chamber where dissolved oxygen (DO), pH, electrical conductivity (EC), turbidity and temperature were measured. When measurements were made using the flow-through chamber, samples were monitored without any interaction with the atmosphere. Figure 4 shows the field setup of the pump and flow-through chamber with the meters used, and GPS. Dissolved oxygen concentrations are particularly susceptible to equilibration with the atmosphere, and care must be taken to ensure that results are as representative of the subsurface as possible. Instrument probes were inserted into each port of a flow-through sampling cell; an airtight seal was obtained by tightening a rubber gasket around the individual probes.

A peristaltic pump was then used to pump water through the flow-through chamber from each of the mini-piezometers. Water was allowed to circulate through the chamber until each of the parameters had adequately stabilized, typically 3 to 5 minutes. Turbidity was measured with a hand-held DRT turbidity meter that uses back-scattered light to measure the turbidity. An Orion 210 pH meter, YSI 95 DO meter, and an Orion Model 128 Electrical Conductivity (EC) were calibrated within 30 minutes of data collection prior to each sampling event. Water samples were also collected and filtered with a 0.45 micron filter, and samples were immediately frozen for preservation. These samples were used for nutrient analysis. Temperature measurements were made using a Fluke thermocouple temperature probe. The temperature probe was inserted to a depth of 30 cm inside the ¼ inch mini piezometers to measure temperatures in the spawning gravel. The temperature probe was calibrated by immersing the probe in boiling water followed by immersion in an ice bath. Temperatures are within one tenth of a degree Celsius.

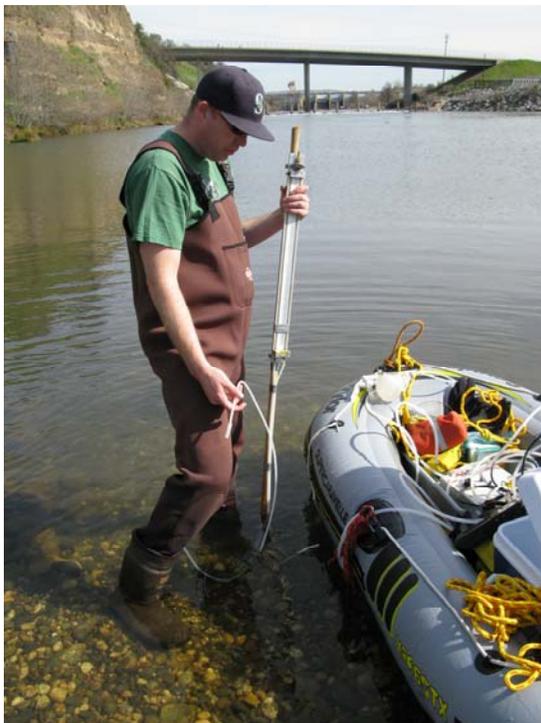
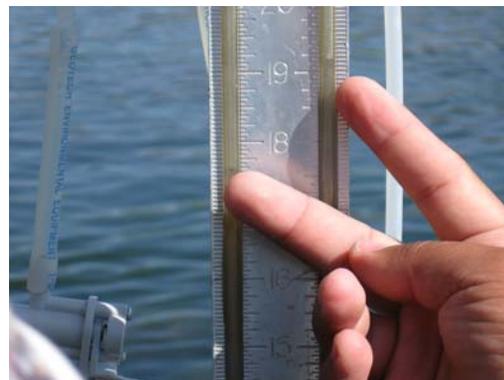
Figure 5: Picture of the manometer used for measuring the upwelling or downwelling for each mini piezometer. The photo to the right shows a close-up view of the different pressure heads from a measurement.

A manometer board was used to measure the difference in pressure head between the piezometers and the bottom of the streambed. The manometer board (Zamora, 2006) consisted of a graduated board with a glass tube in the shape of an inverted “U”.

The glass tube was then attached to the piezometer of interest on one side and a baffle bubble on the streambed bottom on the other side. Figure 5 shows the manometer used for measurements. The tubing from the manometer board was then connected to the baffle bubble. The baffle bubble created an environment that easily equilibrated to the pressure of the streambed, but removed the issue of stream flow past the manometer tubing, which can greatly affect readings in the manometer board. At the top of the glass tube, a release valve allowed water to be drawn into the manometer board from the bottom of the streambed and the piezometer. All devices used to measure the hyporheic zone were calibrated within 30 minutes of field usage where applicable.

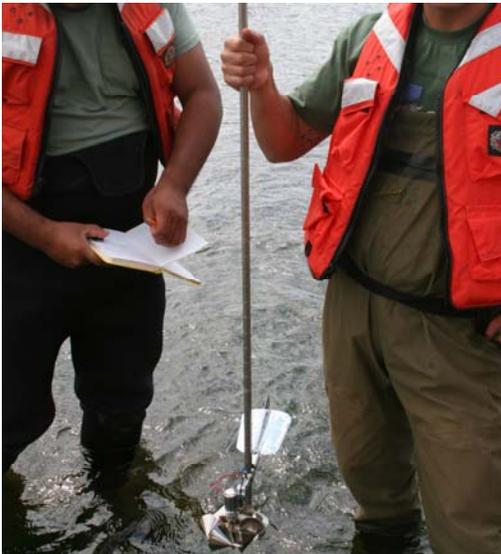
Figure 6: Picture showing the Price AA wading rod stream velocity measuring equipment.

The average of the 0.2 and 0.8 values are compared with the 0.6 depth for measurement accuracy. The 0.8 depth is also the approximate “snout velocity” for spawning salmonids. Velocity was calculated by counting the revolutions per minute from the flow meter and converting to velocities using the equation: $V = 2.2048R + 0.0178$; where R is the number of revolutions per minute, and V is the velocity in feet per minute (converted to feet per second). Figure 6 shows a picture of the equipment used to measure the velocity and depth of the study area.

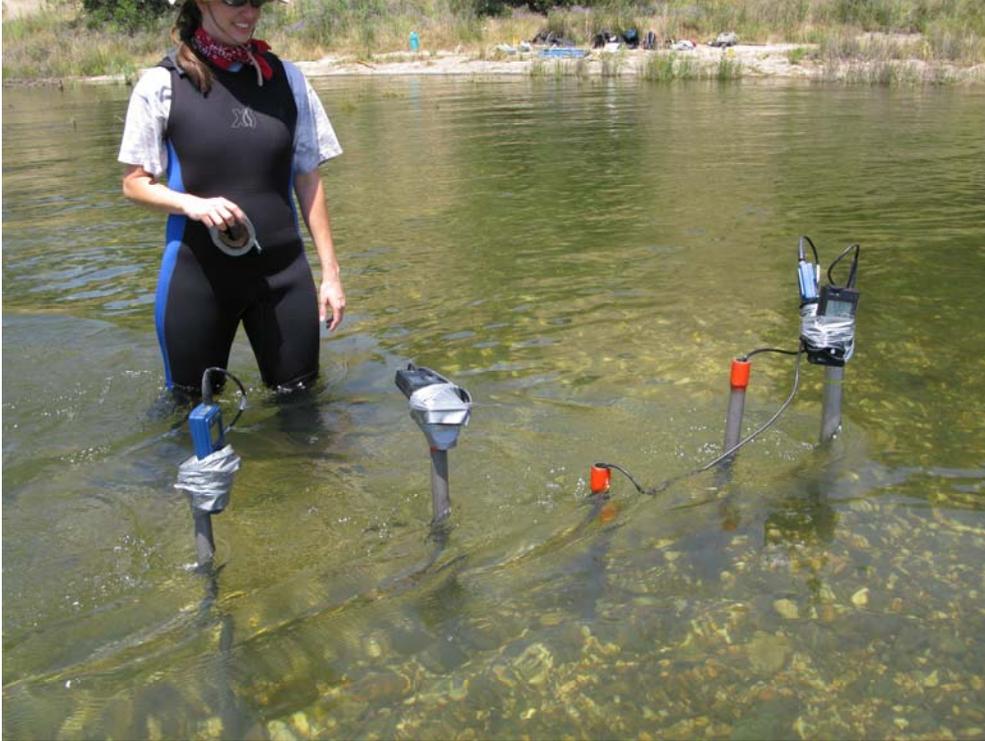
In these tests, a main well or injection well of 1 ¾ inch diameter stainless steel pipe was inserted 30 cm into the subsurface. Three 1 ¼ inch diameter stainless steel pipes (monitoring wells) were installed with 30 cm, 60 cm, and 90 cm spacing downstream from the injection well, to a depth of 30 cm. Each well was purged (developed) prior to tracer measurements. Orion electric conductivity meters were inserted into the injection well and the three monitoring wells. The meters were calibrated 30 minutes prior to each field day used. The background conductivity was measured in each well to verify the meter's accuracy prior to testing. Figure 7 shows the monitoring well configuration for salt water tracer tests with a 30cm monitoring well spacing from the injection well.

Figure 7: Picture showing the field set up of the permeability measurements.

During a typical test, two liters of super-saturated saltwater solution were injected into the main well. The saltwater solution was created by the addition of 5 lbs of rock salt to 3 gallons of water. Salt crystals were still visible in the water 12 hours after the solution was created, and provided visual confirmation that the tracer fluid was saturated with sodium chloride. During each test, each EC meter was monitored for an increase in conductivity as time elapsed. Increases in the conductivity readings were recorded with time until the electrical conductivity readings became stable, or greater than 30 minutes of time had elapsed since the original increase. The electrical conductivity readings in the saturated solution were usually several orders of magnitude higher than the background (river) conductivity readings, giving an obvious electrical signal from the salt plume arrival at each well. This tracer test method is used to provide a graph of electrical conductivity versus time at different monitoring points.

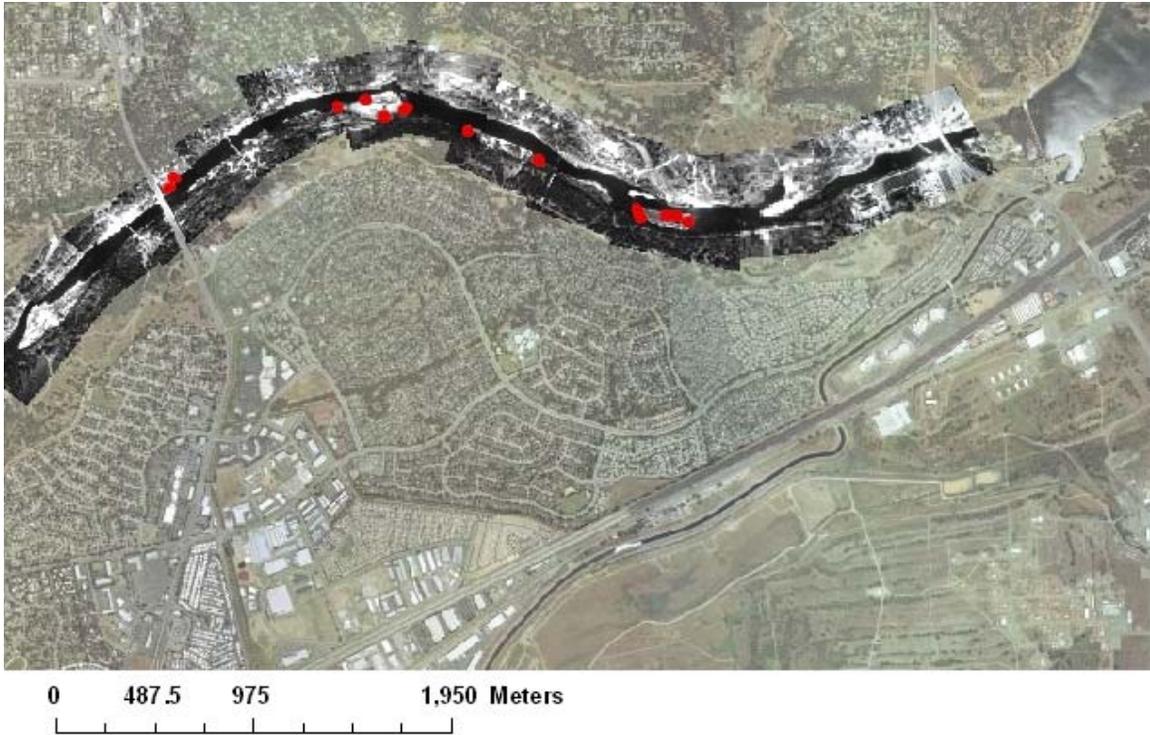
20 Pebble counts were conducted at the restoration site and up to 3 miles downstream from the restoration site before the 2008 restoration project started. The pre-restoration downstream pebble counts showed a range in grain sizes from fine-grained sand to 10 inch diameter boulders. Figure 8 shows the location of the downstream pebble counts. Figure 9 shows the cumulative frequency graph for the 20 pebble counts conducted from the western tip of Sailor Bar downstream to the Sunrise bridge. There was no trend or pattern to the grain size distribution from the upper portion of the study area (Sailor Bar) to the downstream portion of the study area (Sunrise). Median grain size diameters (d_{50}) ranged from 7/16 inch to 1 ¼ inch.

Figure 8: Map showing the downstream pebble count locations with red triangles. Pebble counts were conducted from the 2008 gravel addition downstream to the Sunrise bridge.

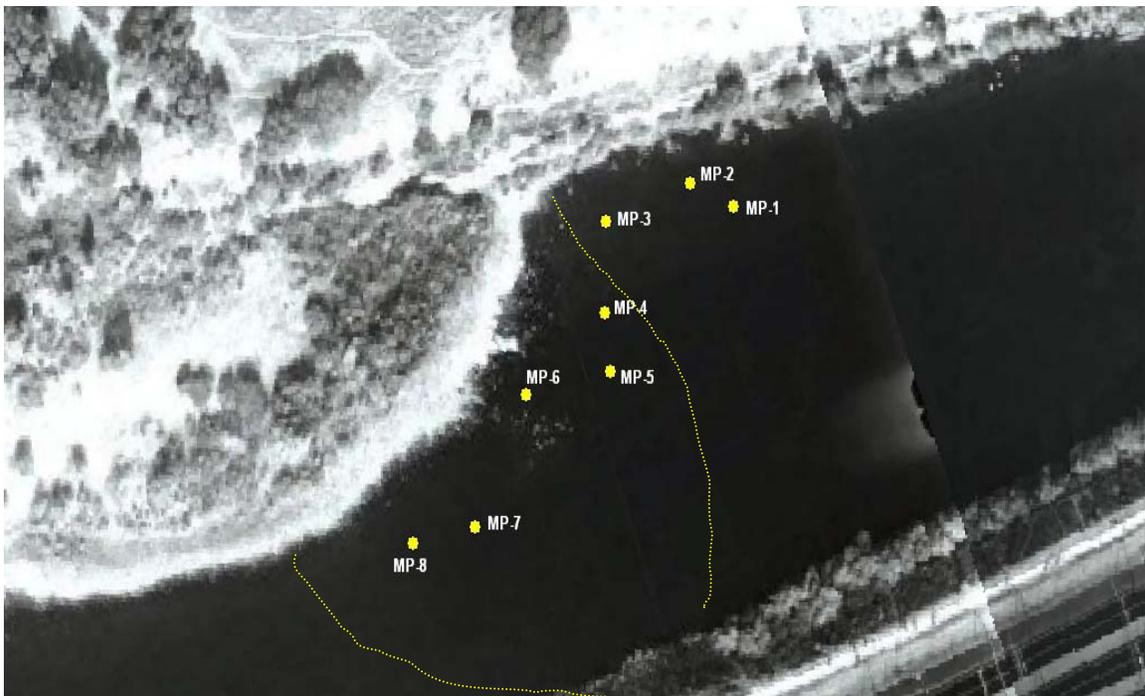
A total of 8 mini piezometers were installed before the gravel addition. Figure 10 shows the location of the mini piezometers before gravel addition. The before restoration water quality data is shown in table 1. Mean dissolved oxygen measurements before the gravel addition (Figure 11) were 4.5 mg/L with a range from 1.1 mg/L to 7.65 mg/L. The mean electrical conductivity for the gravel before restoration was 51.3 micro Siemens with a range from 37.2 micro Siemens to 69.4 micro Siemens. Mean pH for the gravel before restoration was 6.8 with a range from 6.6 to 7.2. Mean temperature at a depth of 30 cm in the gravel (before restoration) was 22.0 degrees Celsius. Gravel temperature measurements ranged from 21.6 degrees Celsius to 22.0 degrees Celsius.

Figure 10: Before gravel addition map showing the gravel addition area outlined in yellow. Points are mini piezometer locations used to sample pre restoration and control hyporheic water quality.

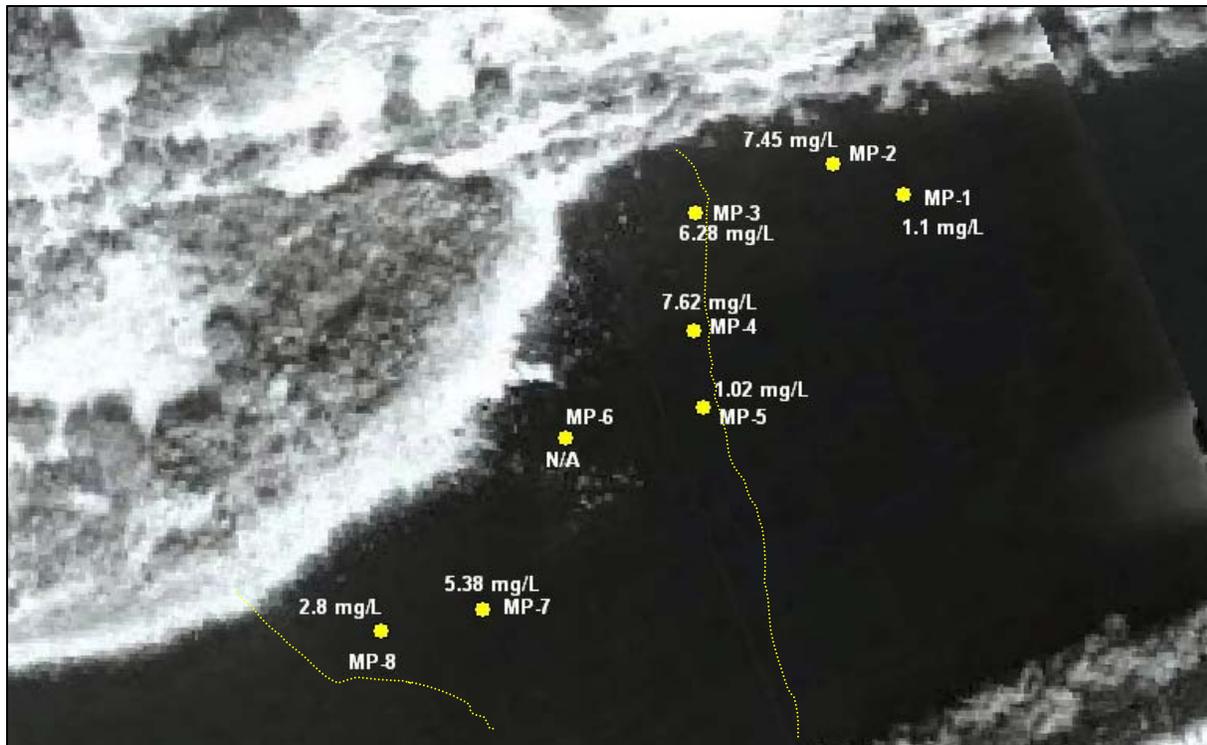
Figure 11: Before gravel addition map of the study area showing dissolved oxygen readings, September 2008.

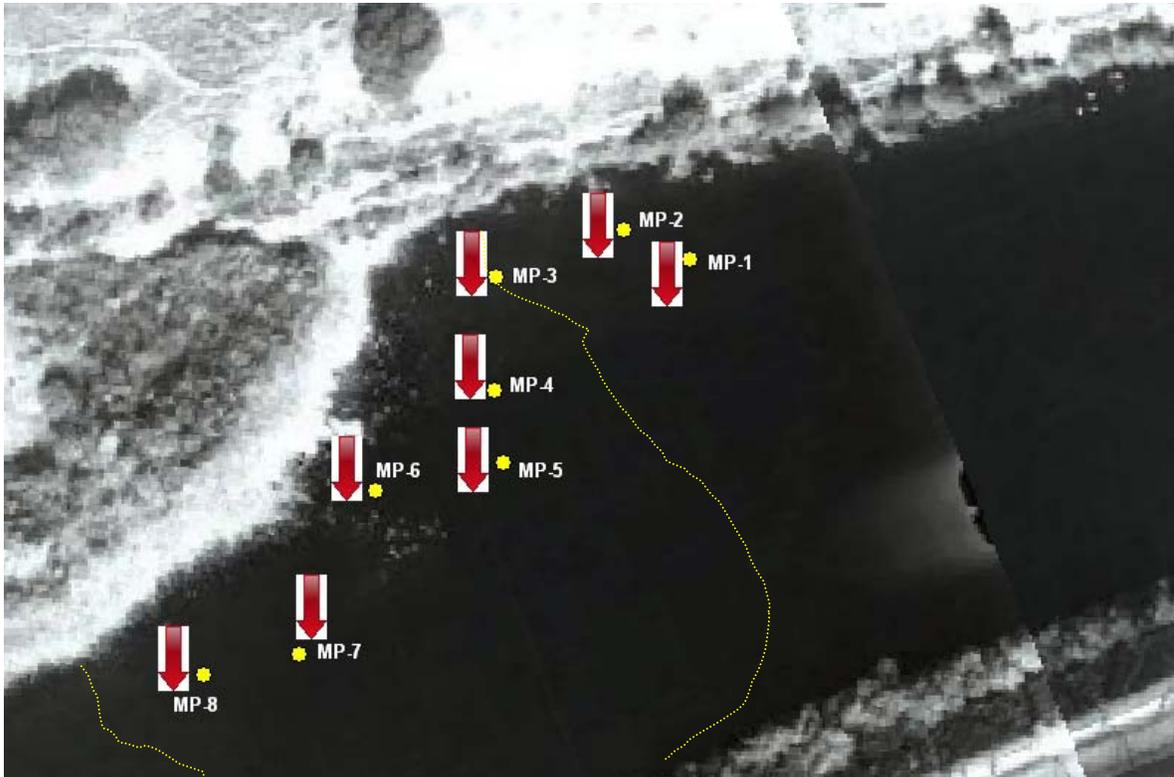
Upwelling and downwelling measurements made before the gravel addition all showed downwelling conditions. Figure 12 shows the upwelling/downwelling map for the pre gravel addition area.

Figure 12: Before gravel addition upwelling/downwelling measurements. The red arrows pointing downward indicate downwelling.

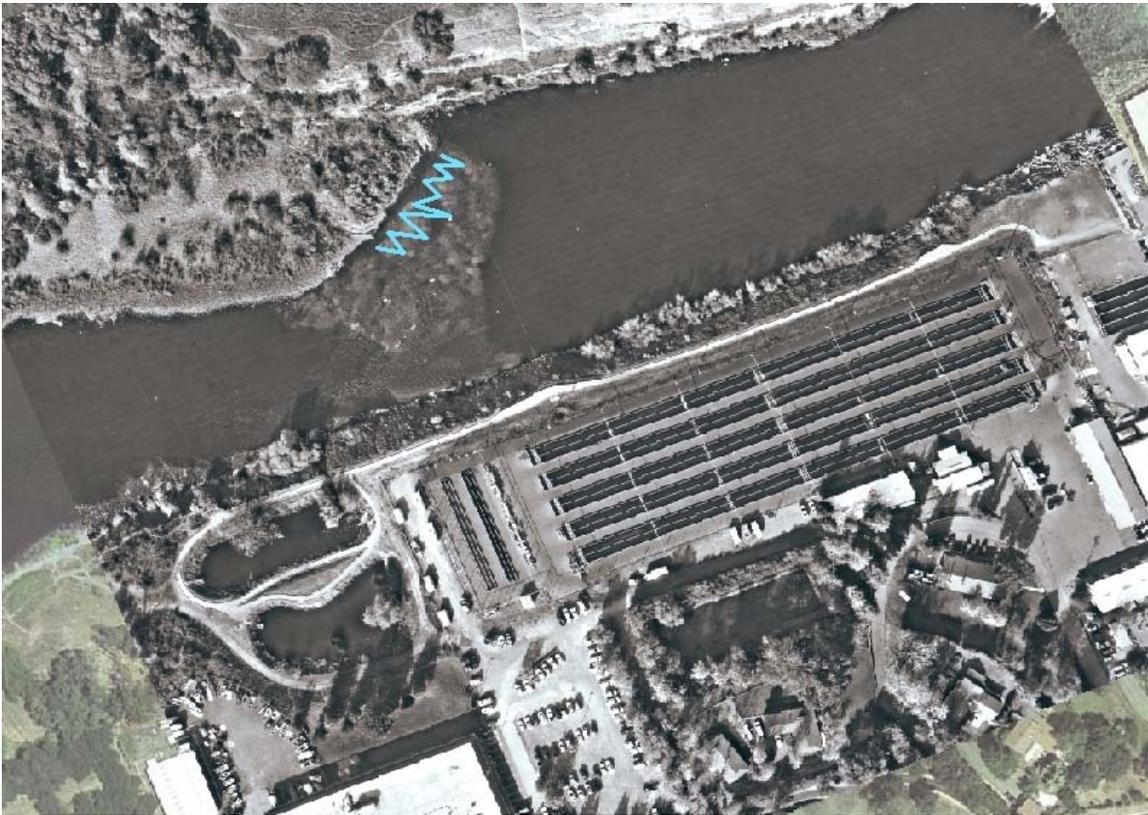
9 Pebble counts were conducted in June 2009 after the gravel addition was completed. Figure 13 shows a map of pebble count locations. Figure 14 shows the cumulative frequency graph for the pebble counts conducted after restoration. Median grain size diameters (d_{50}) ranged from 5/8 inch to 7/8 inch. Appendix B shows the data from the pebble counts.

Figure 13: After gravel addition map of the pebble counts conducted in June 2009

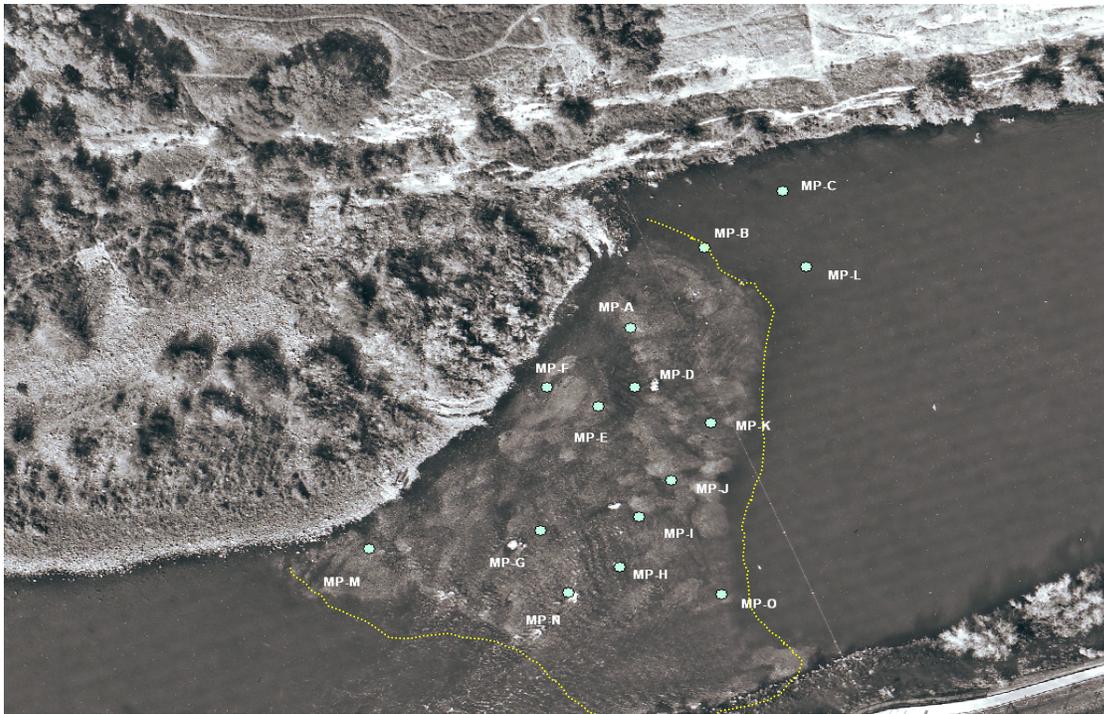
15 mini piezometers were installed in December 2008 after the gravel addition. Figure 15 shows the location of the mini piezometers after the gravel was added. Table 3 shows the water quality data for the post gravel addition area sampled in February and June, 2009. Water samples were collected before and after gravel addition measuring for Nitrate, Nitrite, Phosphate, and Ammonia. None of the samples showed values higher than the lowest detectable limits for any of the water samples. Appendix C shows the HACH chemistry data for the before and after gravel addition water chemistry analysis. Most of the water samples measured barely showed the lowest detectable limits for the given test; none of the samples contained even moderate concentrations of anything measured.

Figure 15: After gravel addition map showing the gravel addition area. Points indicate mini piezometer locations. MP C and MP L are upstream of the gravel to provide control measurements.

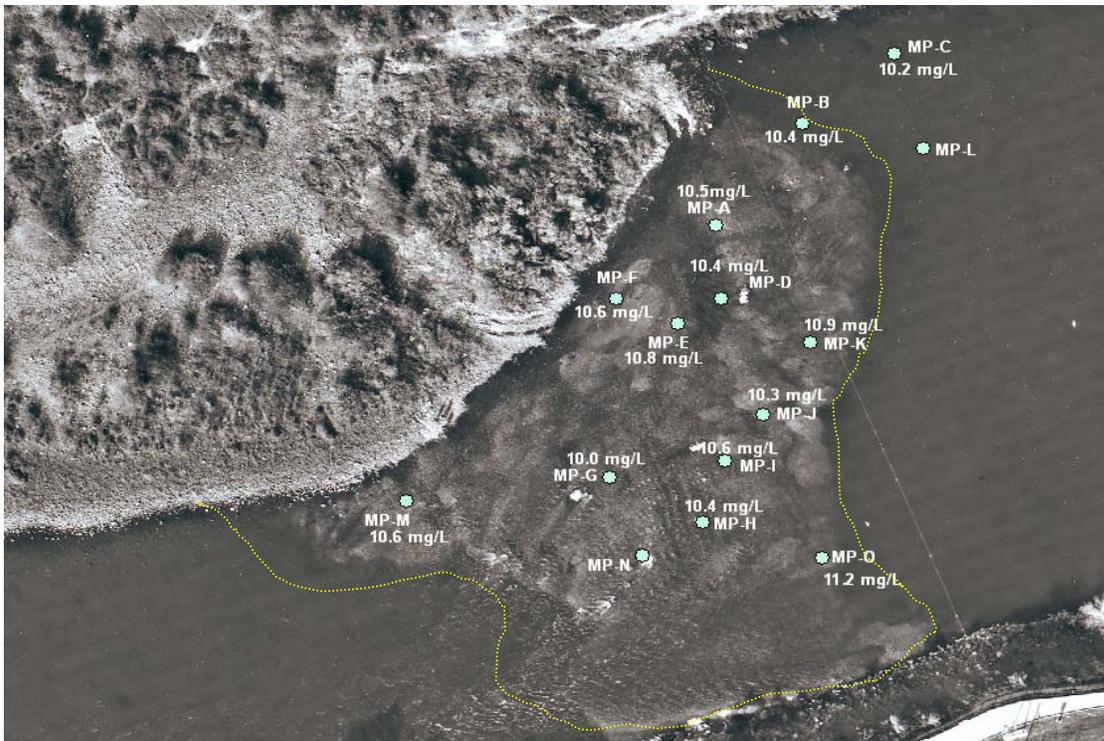
Figure 16: After gravel addition map of the study area dissolved oxygen readings February 2009.

Mean E.C. measured after the gravel addition was 79.6 μ s with measurements ranging from 78 μ s -82 μ s. The mean D.O. recorded (Figure 16) was 10.5 mg/L with a measurement range of 10.0 mg/L to 11.2 mg/L. The mean pH was 7.4 with a range from 7.1 to 7.5. The mean temperature recorded was 9.6 degrees Celsius with a range from 9.2 to 10.2 degrees Celsius.

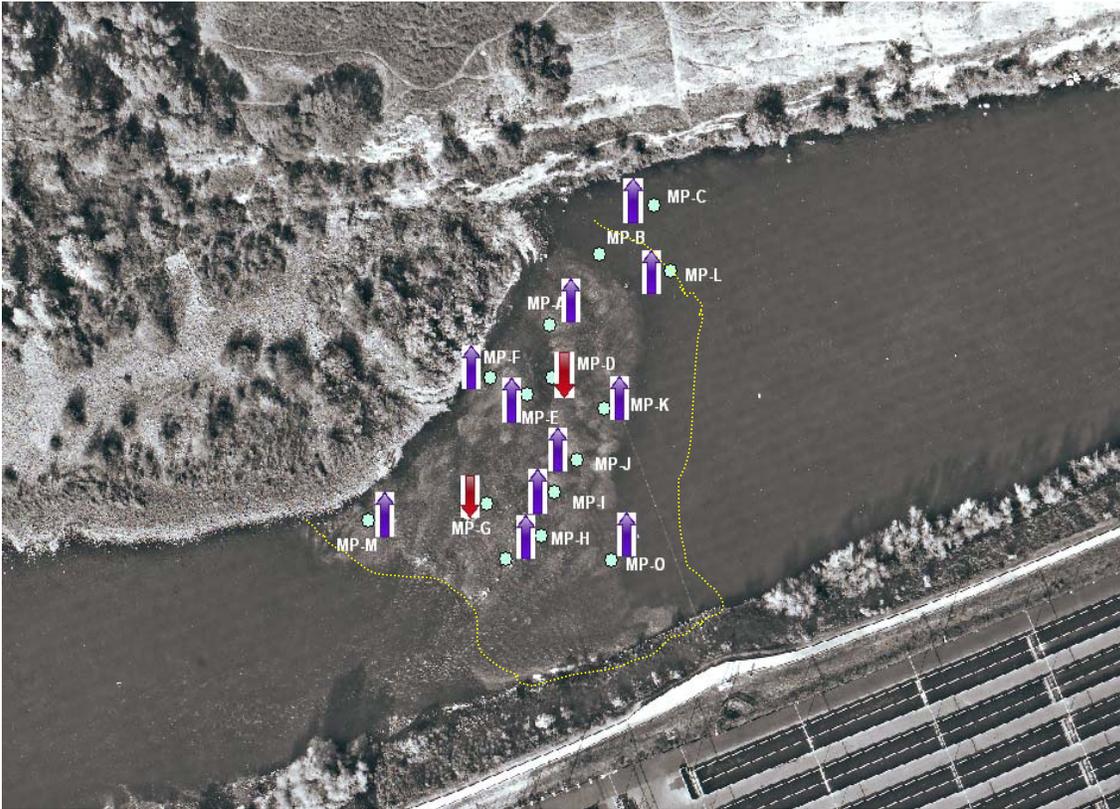
Figure 17 shows the upwelling/downwelling map for the post gravel restoration area.

Measurements were made in February 2009 with a river flow approximately 750 cfs.

Figure 17: After gravel addition map showing upwelling/downwelling measurements. The red arrows pointing downward indicate downwelling, the purple arrow pointing upward indicate upwelling conditions February 2009.

Physical and hydrologic measurements conducted at the Sailor Bar gravel addition site indicate a positive effect in terms of improving spawning habitat. Inter gravel velocities and dissolved oxygen measurements are both elevated in the new gravel. The gravel addition has also had a stabilizing affect on the pH, electrical conductivity, and temperature. Hyporheic pressure changed from complete downwelling prior to restoration to almost complete upwelling after the gravel was added.

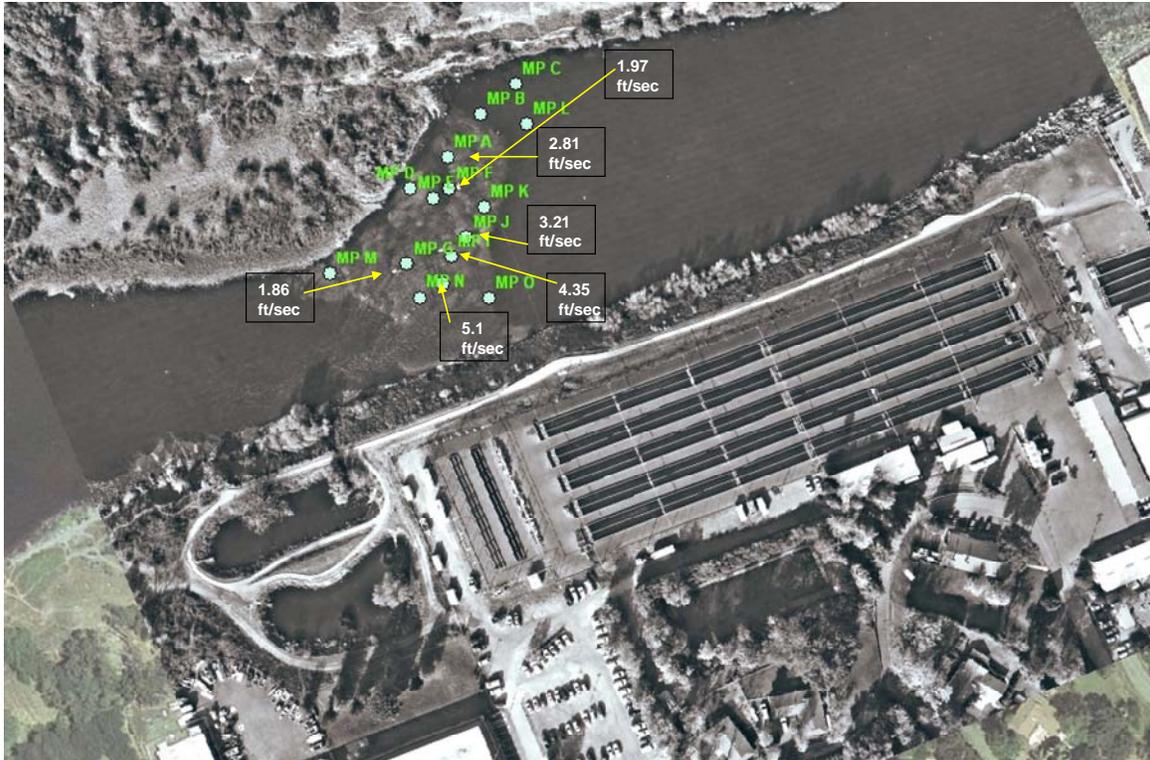
Velocity and depth were measured in February 2009, after the gravel was added. Table 5 shows the depth and velocity measurements. The flow for the February 21, 2009 sampling event was 780 cfs. The low flow caused many locations to be too shallow to measure the stream velocity for the post gravel addition data. The mean velocity for the restoration area was 2.55 feet per second. The mean depth was 0.9 feet. Figure 18 shows the locations of the velocity measurements.

Figure 18: After gravel addition map showing average surface water velocity measurements in February 2009. Stream flow was 780 cfs. Mini piezometers without velocity values were either too shallow or less than 1 foot per second.

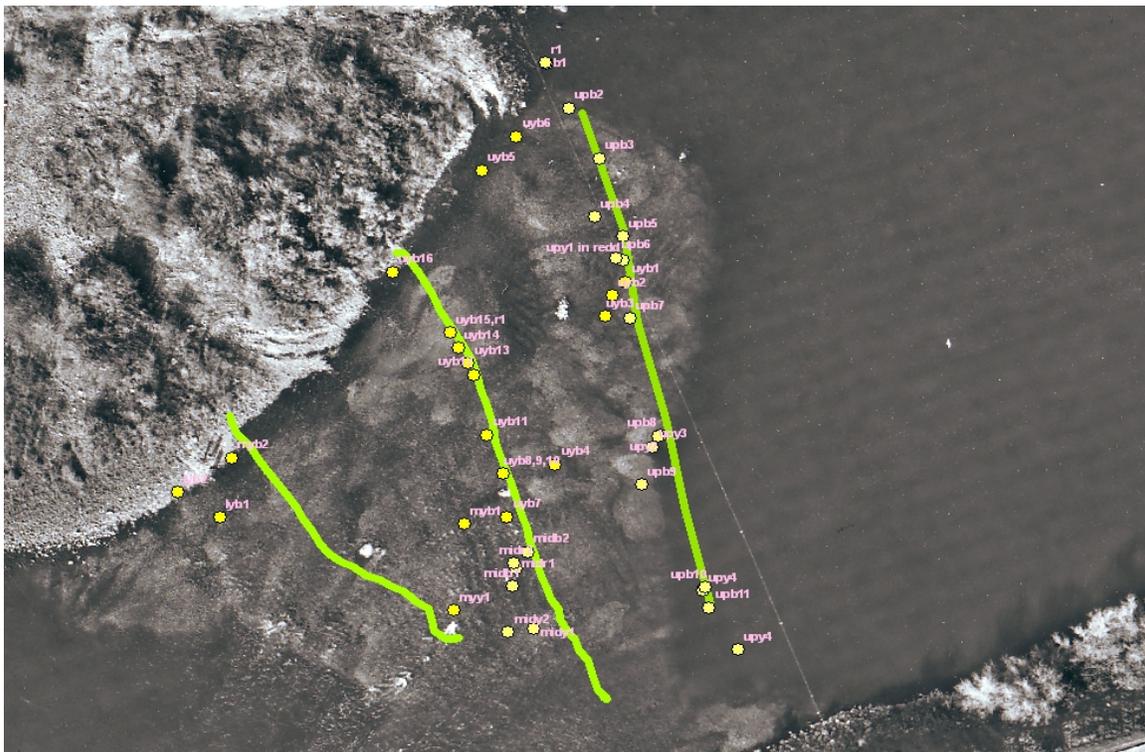
Figure 19 shows the tracer rock transects installed after gravel addition. The gravel addition is highlighted with a (yellow) dotted line. The furthest downstream transect lost the southern 1/3 of the tracer rocks, almost immediately to a blowout or loss of gravel. The middle and upper transects also lost considerable rocks to either burial or movements by fish during the salmon redd building process. This was witnessed on multiple occasions by the field crew. Substantial numbers of yellow and blue rocks were located 8 months after the gravel addition was completed. The upper transect recovered 19 large (yellow, 2 ½ -3 inch) rocks, 12 intermediate-sized (blue, 1 ¼ - 1 ¾ inch) and 6 small-sized (red, 5/8 – 7/8 inch) rocks. The middle transect recovered 17 large rocks, 9 blue rocks and 7 red rocks. Only 5 rocks from the lower transect were located.

After 8 months, and flows up to 5000 cfs. Most of the yellow rocks did not move. There was minor movement of yellow rocks in the high velocity portion of the gravel addition. The middle transect showed a similar pattern, and the downstream transect was either buried or washed out. Few rocks were located from the downstream transect. Blue tracer rocks were mobile in the upper and middle transects, moving up to 20 meters. Red tracer rocks moved the furthest and yielded the smallest number of rocks located due to burial or removal from the area.

Figure 19: After gravel addition map showing the tracer rock transects from June 2009. Yellow points indicate rocks located.

Tracer rocks studies showed that the smallest tracer rocks ($5/8''$ to $3/4'$ were mobilized and washed downstream from the study area by this year's maximum flow of 5000 cfs. Many of the intermediate and largest tracer rocks were still present in the new gravel area 8 months after the rocks were inserted, moving up to 20 meters in some cases.

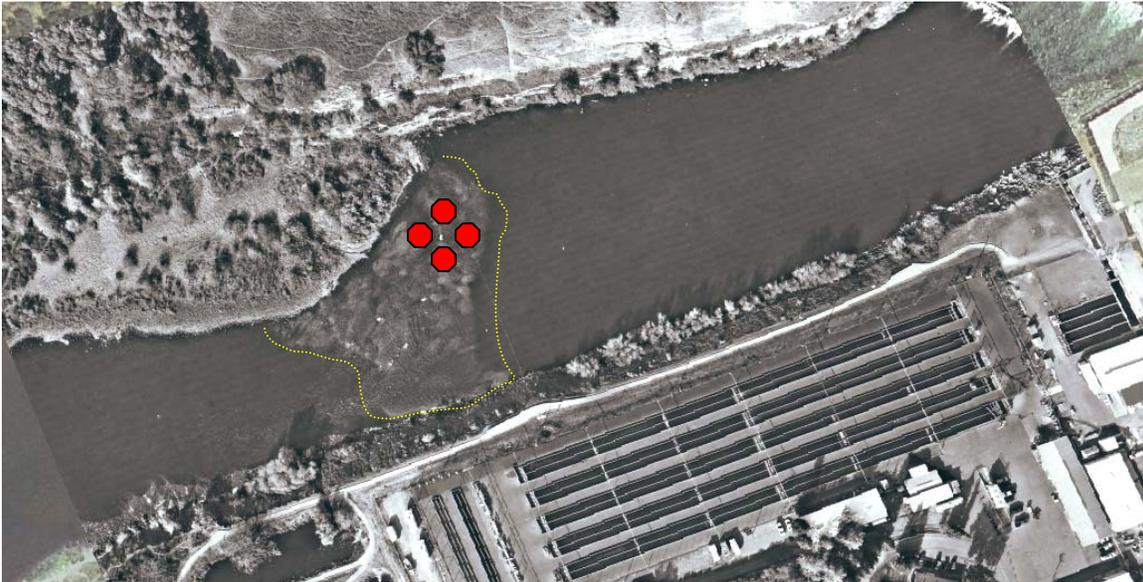
Figure 20: After gravel addition map of the salt water tracer tests. Tracer tests were conducted in March 2010.

Four salt water tracer tests were conducted at Sailor Bar in March 2010. The location of these tracer tests is shown on Figure 20. Figures 21-24 show graphs of electrical conductivity versus time for the 4 tests. The tracer tests yielded inter gravel velocities of 10 cm/min to 50cm/min, at a depth of 30 cm and 18 months after restoration work. A monitoring well, spaced 10 cm from the injection well showed elevated electrical conductivity values immediately after sodium chloride injection for every test. Inter gravel velocities for the 10 cm and 20 cm monitoring wells were between 20 cm/min and 50 cm/min. The velocities recorded at the 30 cm and 40 cm distances were between 10 cm/min and 12 cm/min. Distances greater than 50cm from the injection often missed the tracer plume except for test 2, where the monitoring well 47 cm from the injection well showed a velocity of 24 cm/min. The tracer test was added at time= 0; and the arrival time is taken as the midpoint of the E.C. curve for each monitoring well.

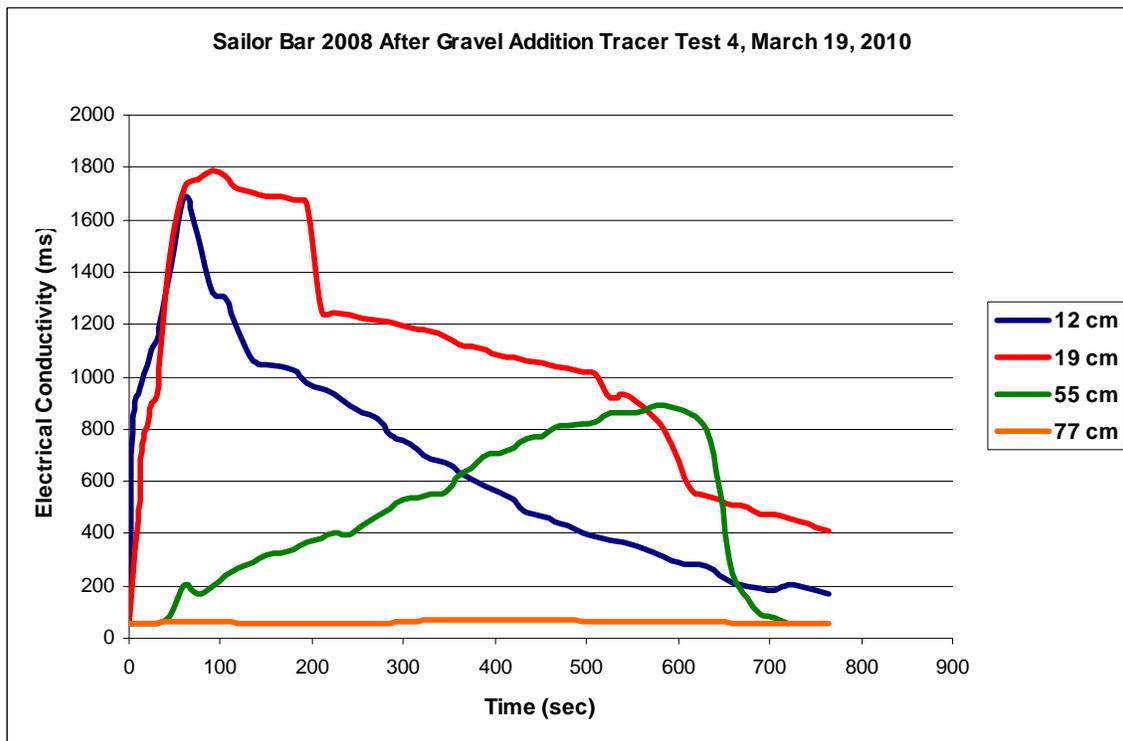
Figure 24: Electrical conductivity versus time graph of salt water tracer test 4 from Sailor Bar, March 2010.

Salt water tracer tests has showed the gravel addition to be highly permeable with seepage values of 20 cm/min to 50 cm/min within 20 cm of the injection well, with the 10 cm monitoring well having an immediate reaction to the sodium chloride at all tests. Velocities decreased to 10 cm/min and 14 cm/min at distances of 30 cm to 40 cm away from the injection well. Only one monitoring well observed changes more than 50 cm away from the injection well during testing, having a velocity of 14 cm/min. These times indicate rapid movement of water between the pore spaces in the tested locations.
